**GOVERNMENT OF THE DISTRICT OF COLUMBIA
OFFICE OF THE INSPECTOR GENERAL**

**METROPOLITAN POLICE
DEPARTMENT**

**INSPECTION OF
STATION AND SUBSTATION BUILDING
CONDITIONS**

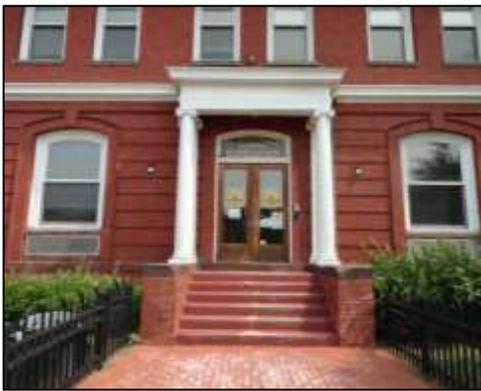
Condition: None of the three MPD substation entrances were equipped with wheelchair ramps and other accessibility features, e.g., automated doors.⁸

Figure 2: First District Substation Entrance Without a Ramp

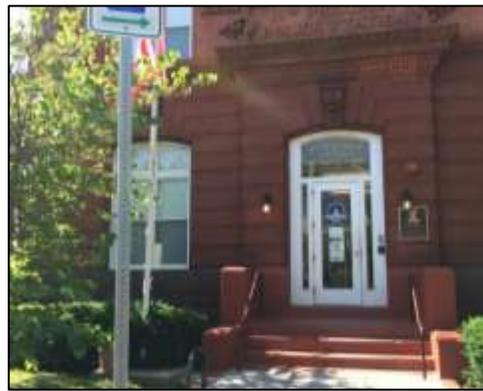
Figure 3: Fourth District Substation Entrance Without a Ramp

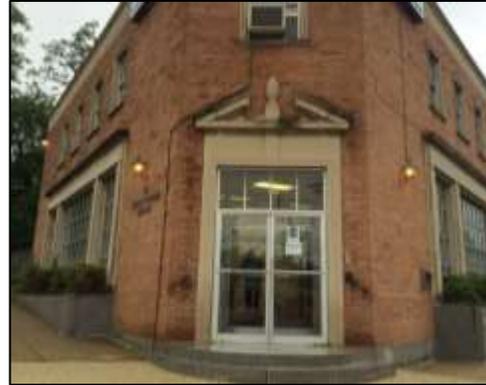
Figure 4: Sixth District Substation Entrance Without a Ramp

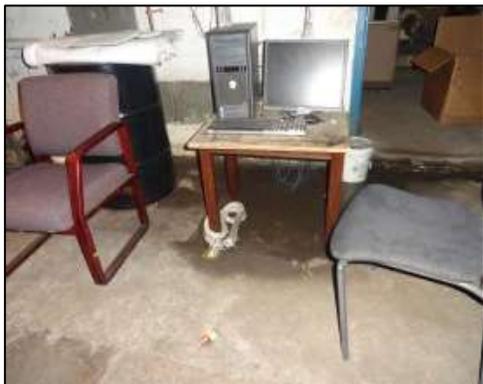
Figure 6: Example 1 of leak in boiler room in First District Station

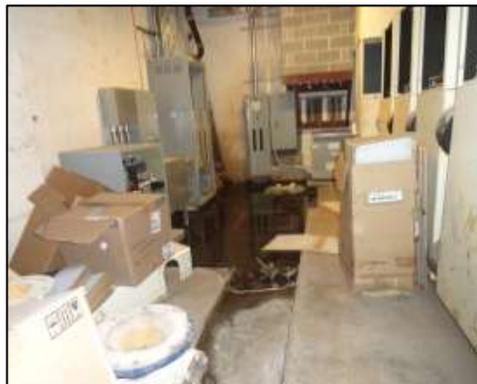
Figure 7: Example 2 of leak in boiler room in First District Station

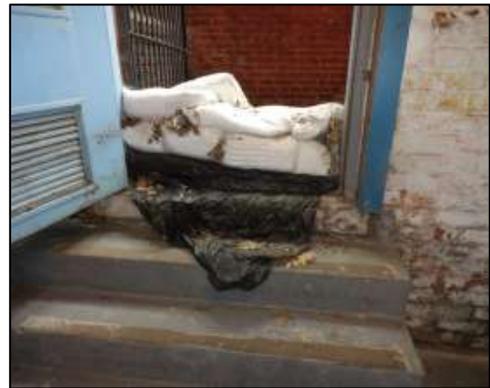
Figure 9: Sandbags outside exterior boiler room door of the First District Substation

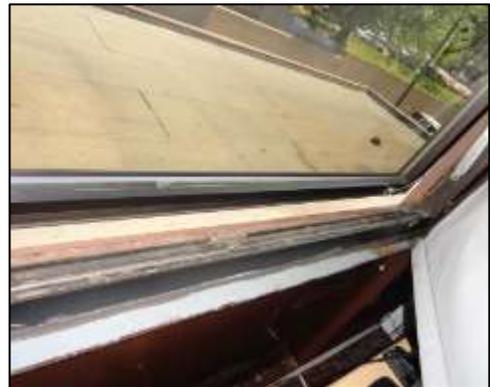
- windows in eight rooms (mostly on the second floor) that did not close and lock properly, which may result in air conditioning and heat escaping, water entering the station, increased maintenance and repair needs, decreased employee comfort, and window sills with peeling and rusted paint;
- water-stained ceiling tiles, indicative of leaks, were present in: the men’s locker room (one officer noted that there was a long-standing leak in the locker room), room 003, and five additional rooms, which may negatively impact employee comfort, cause mold, and lead to cosmetic and structural damages;
- inconsistent air conditioning and dirty HVAC vents in eight rooms may affect employee health and comfort;
- electrical issues, such as cords hanging from the ceiling and wires taped around doorways, may adversely impact employee and visitor safety;

Figure 12: Window that would not latch at Second District Station

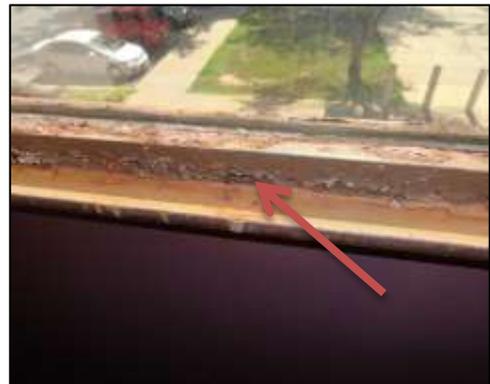
Figure 11: Figure 12: Peeling paint/rust on window sill at Second District Station

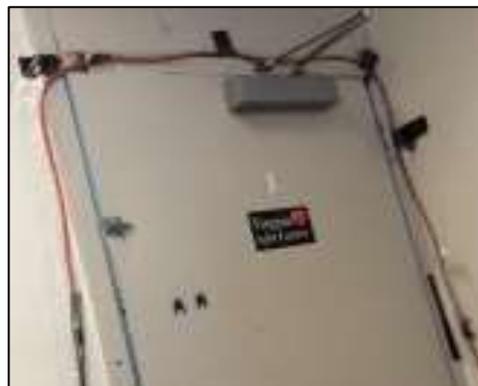
Figure 13: Example of an electrical wiring issue at Second District Station

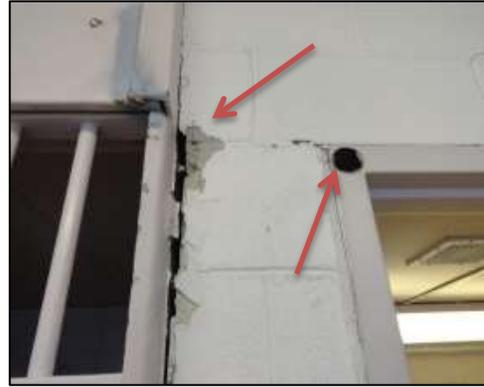
Figure 15: Holes and cracks by holding cells at the Third District Station

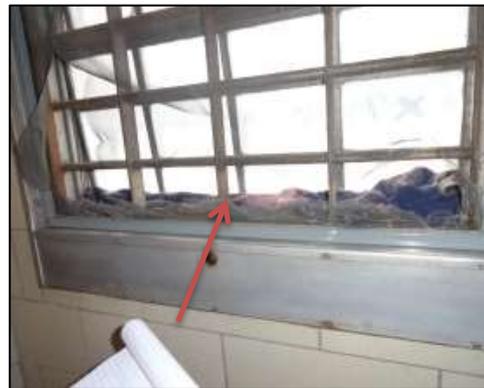
Figure 16: Dirty towel behind broken screens at the Third District Station

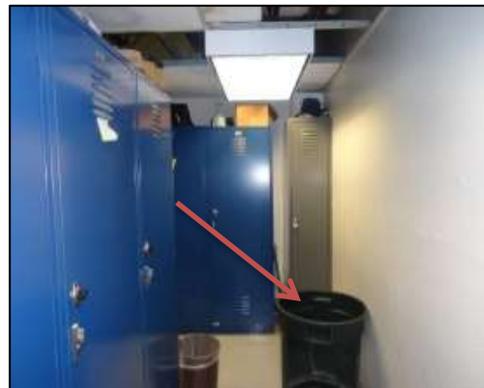
- evidence of water leaks such as: standing water outside the exterior door to the boiler room, leaks in one of the men's locker rooms used by MPD officials and a garbage bin filled with water in this room, stained ceiling tiles in 12 rooms, and bubbling paint below windows sills in 3 rooms;
- windows in four rooms would not latch and close properly and/or were secured with objects;
- inconsistent air conditioning (e.g., the lactation room, evidence storage room, and report writing room were uncomfortably warm) and dirty HVAC vents in nine rooms, which could negatively affect employee health and comfort;

Figure 17: Evidence of leak in officials' locker room at the Third District Station

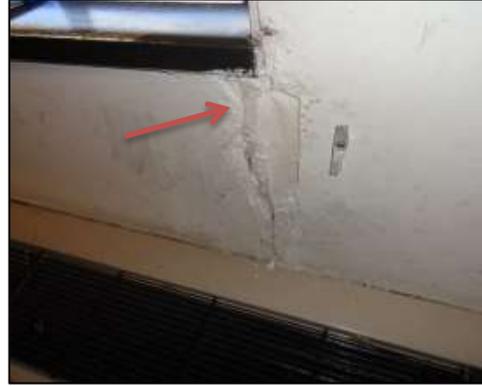
Figure 18: Water damage under window sill at the Third District Station

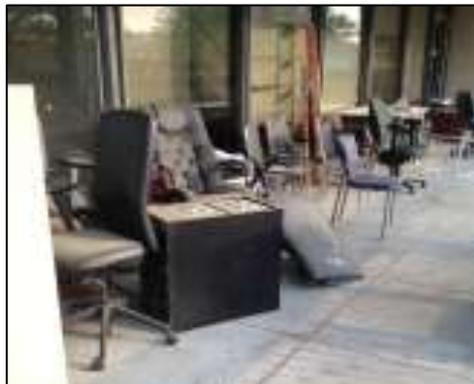
Figure 20: Example of surplus items at the Fourth District Station

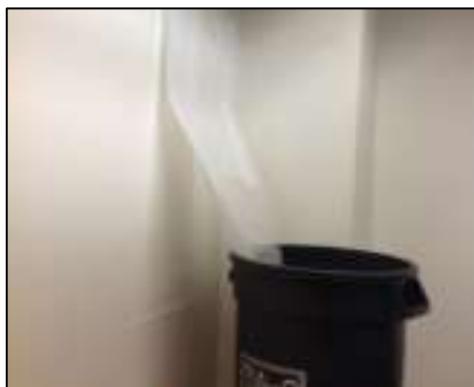
Figure 21: Garbage bin for leak at the Fourth District Station

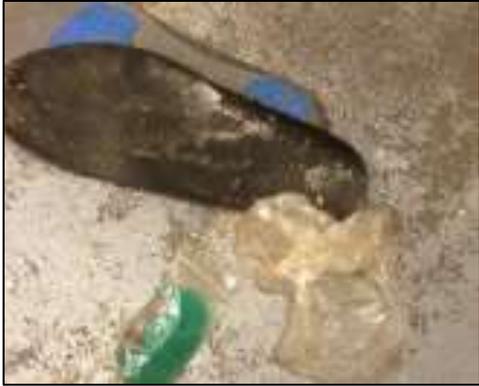
Conditions noted during our inspection: The most concerning conditions in this station were located in the holding cell area. Small holes in the wall caused by plaster deterioration were present behind the toilet inside the largest holding cell, which allowed prisoners to hide contraband.³⁹ While we were on-site, an MPD officer reached into one of these holes and found two shoe insoles, “baggies” used for narcotics, as well as an old razor blade. The officer noted that this deterioration has been a longstanding condition. The light in the female restroom in the holding area provided another potential place for prisoners to store contraband, but no contraband was observed in this location. Additionally, the clock in the processing area of the holding area was broken and had sharp plastic edges, which could be used as a weapon. These conditions are safety concerns.

Figure 24: Items discovered in holes behind cell toilet at the Fifth District Station

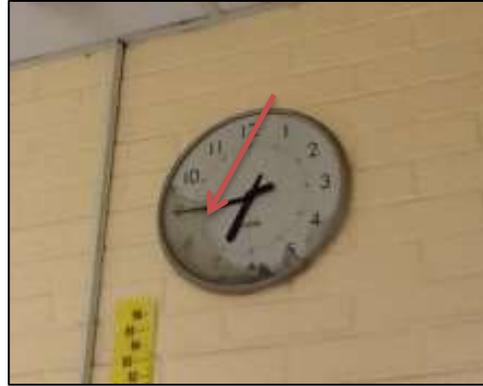
Figure 25: Clock in processing area at the Fifth District Station

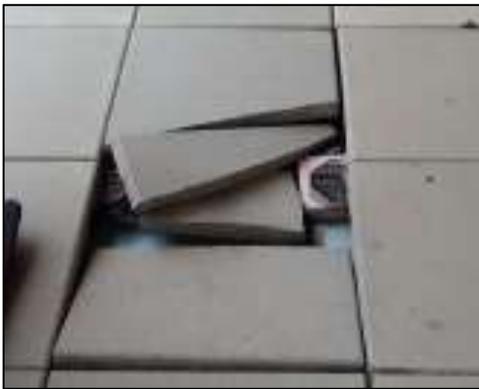
Figure 26: Example of broken walkway tiles at the Fifth District Station

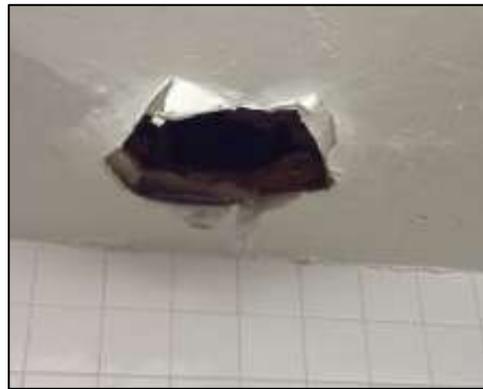
Figure 27: Hole in men's visitor's restroom at the Fifth District Station

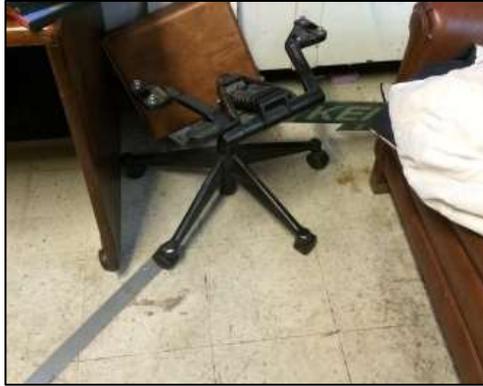
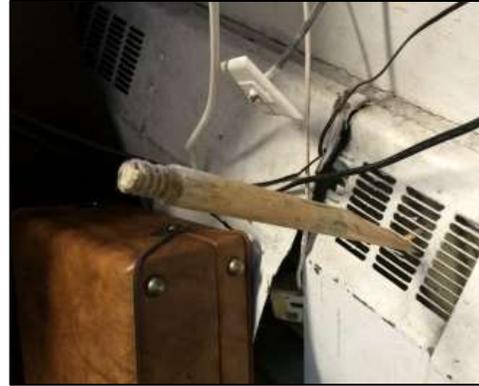
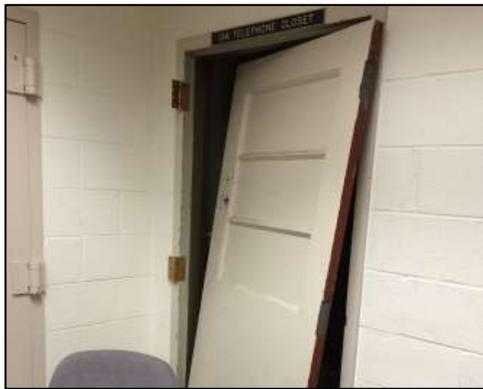
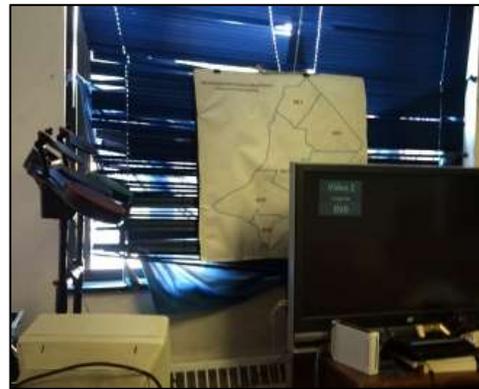
Conditions noted during our inspection: Room 140 (the area used by undercover officers) was in the worst condition; it contained safety hazards such as a door off its hinges and storage behind it, broken blinds, and surplus materials.

Figure 29: Image 1 of room 140 at the Sixth District Station

Figure 30: Image 2 of room 140 at the Sixth District Station

Figure 31: Image 3 of room 140 at the Sixth District Station

Figure 32: Image 4 of room 140 at the Sixth District Station

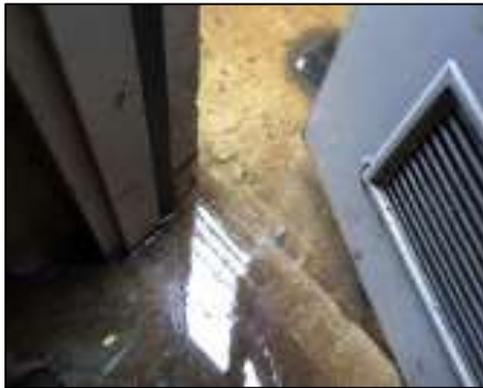
Figure 33: Water outside boiler room at the Sixth District Station

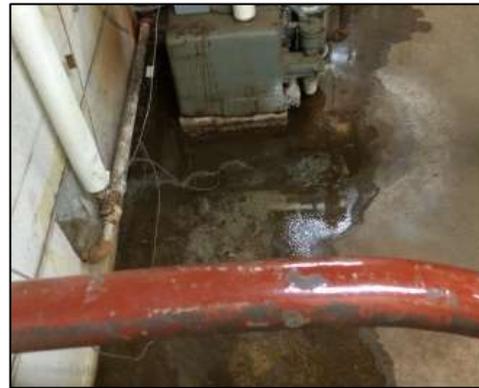
Figure 34: Water inside boiler room at the Sixth District Station

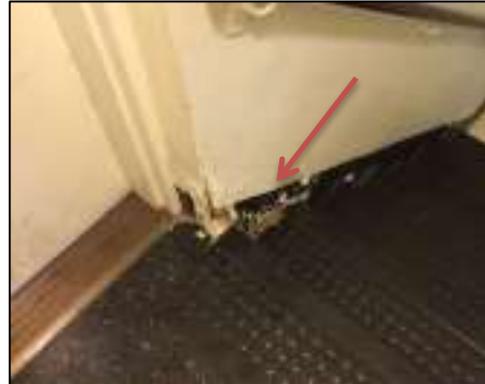
Figure 36: Evidence of water damage by back door at the Sixth District Substation

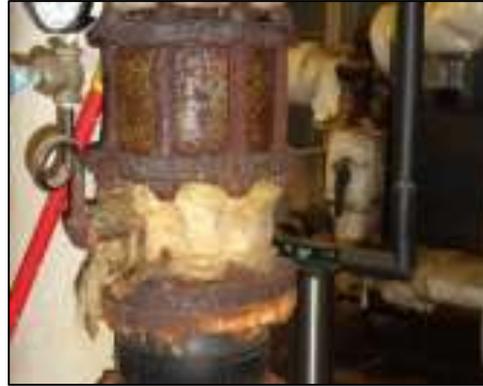
Figure 38: Example of corroded equipment in boiler room at the Seventh District Station

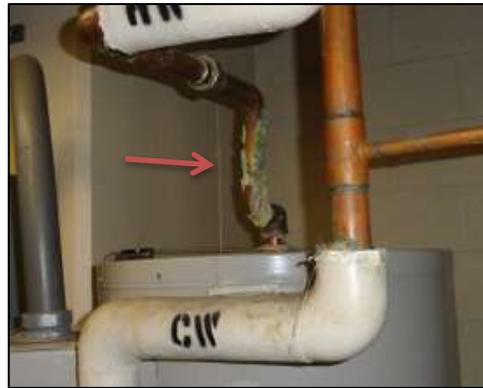
Figure 39: Possible corroding pipes on water heater at the Seventh District Station

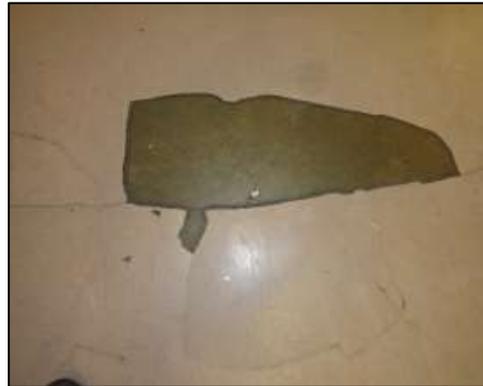
Figure 40: Floor in holding area at the Seventh District Station

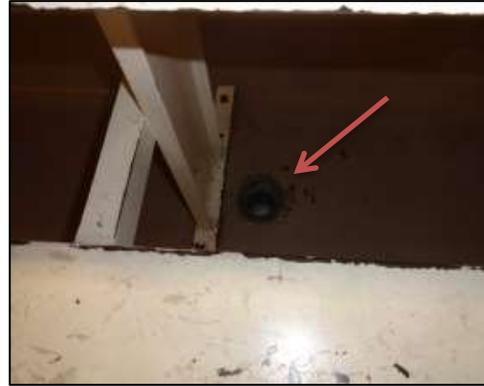
Figure 41: Drain cover missing in cell under table at the Seventh District Station
