**GOVERNMENT OF THE DISTRICT OF COLUMBIA
OFFICE OF THE INSPECTOR GENERAL**

REPORT OF RE-INSPECTION

**CONDITIONS IN FIRE AND EMERGENCY
MEDICAL SERVICES DEPARTMENT
FIRE STATIONS**

November 2012

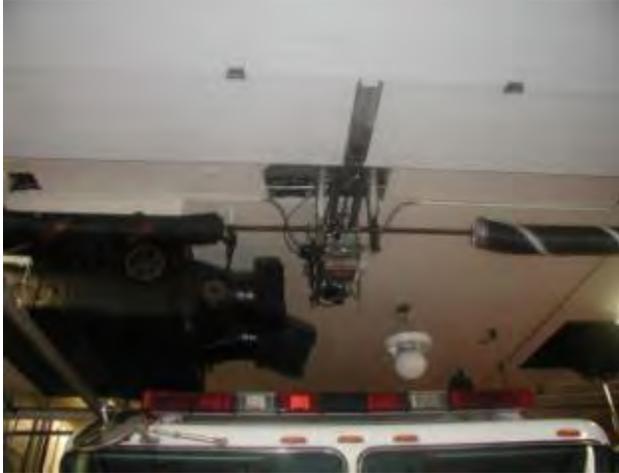
Broken hinge on apparatus bay door

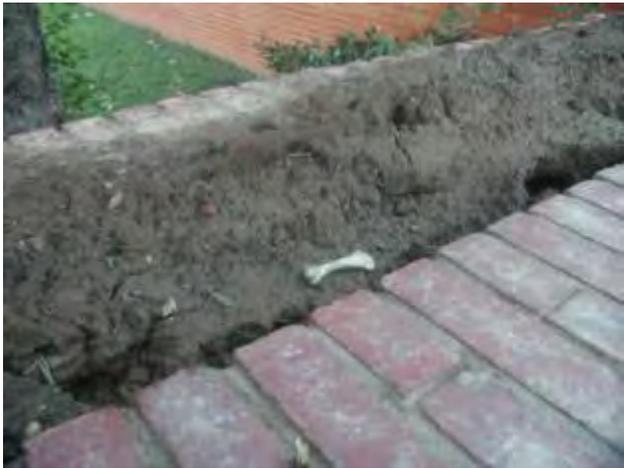
Rodent holes, droppings, and food particles

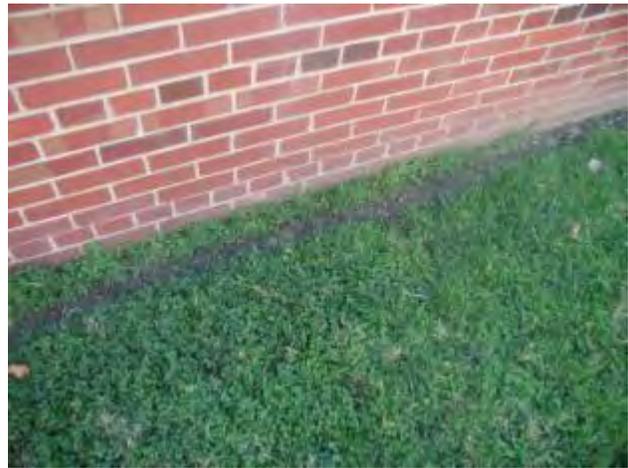
Rodent trail adjacent to station

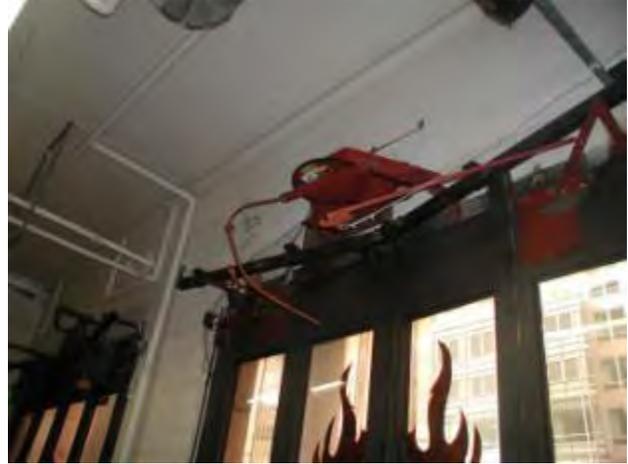
Broken hinges on apparatus doors

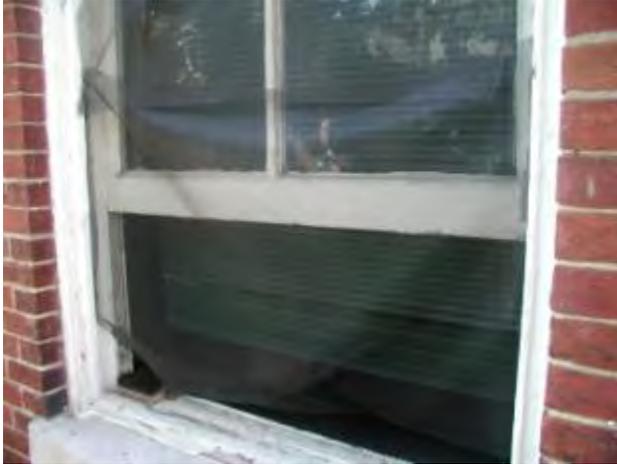
Improper screening

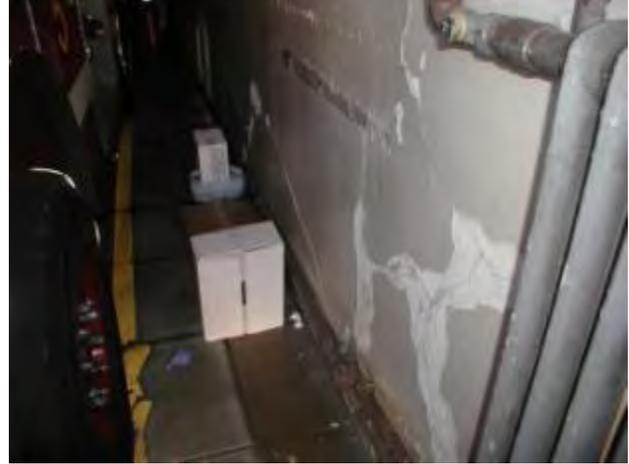
Cracks and damage to walls in apparatus bay

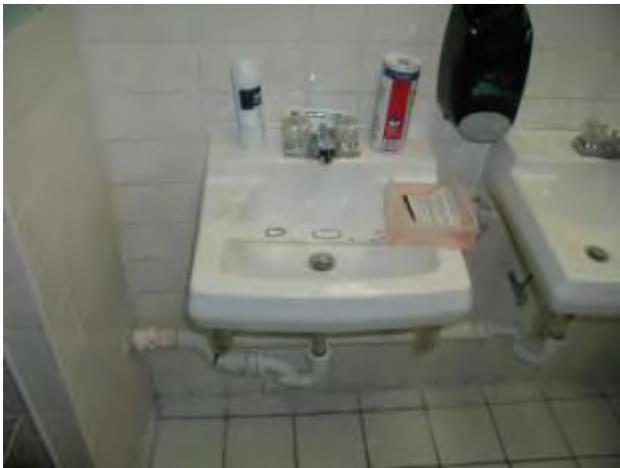
Leak in bathroom sink: Employees reported the presence of a serious leak in the leftmost sink in the men's locker room. The sink leaks water onto the bathroom floor, which seeps through the floor and onto the apparatus in the bay downstairs. An employee said this leak had existed for 3 weeks.

Broken sink in men's bathroom

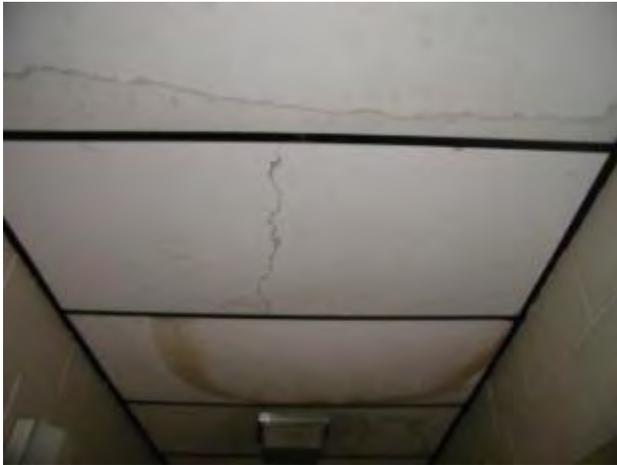
Water damage: The team observed ceiling tiles in the walkways, hallways, and living areas with water damage.

Water damage in hallway

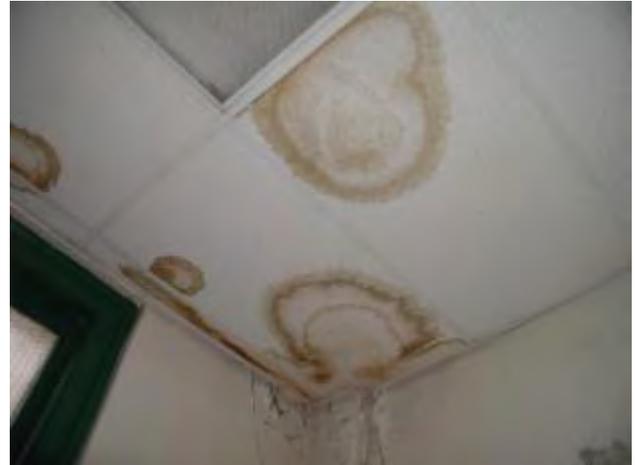
Water damage to ceiling of living areas

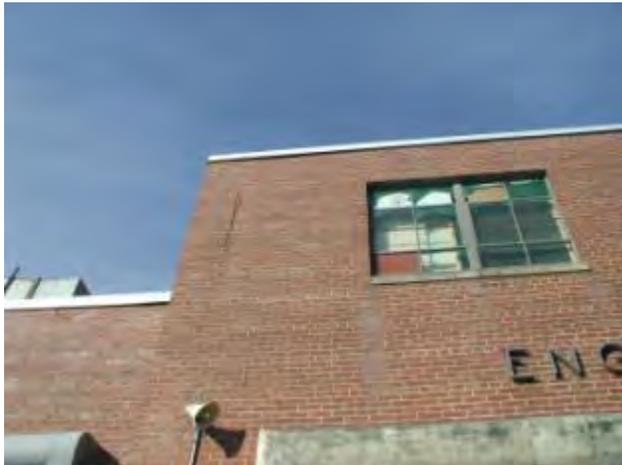
Large crack on exterior wall

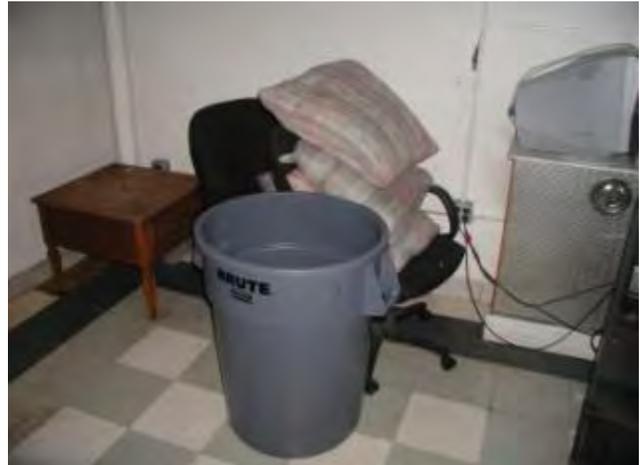
Trash can used to collect leaked water

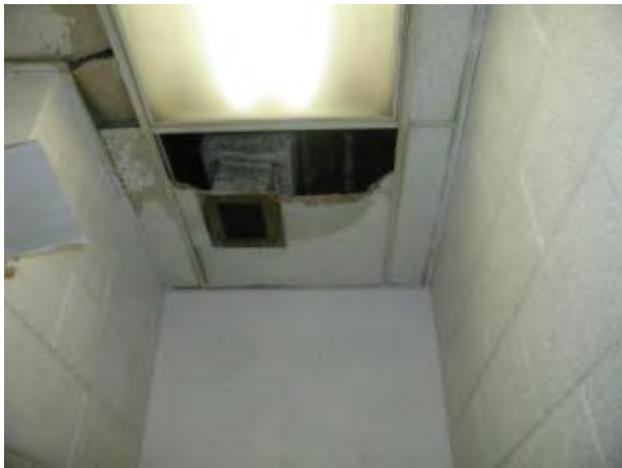
Water damage on ceiling

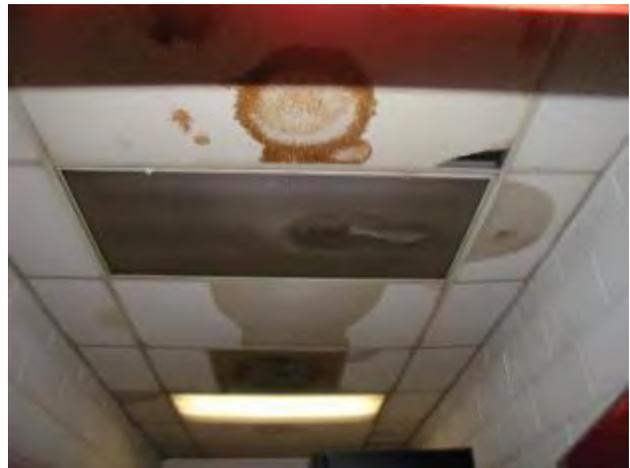
Water damage on ceiling in hallway

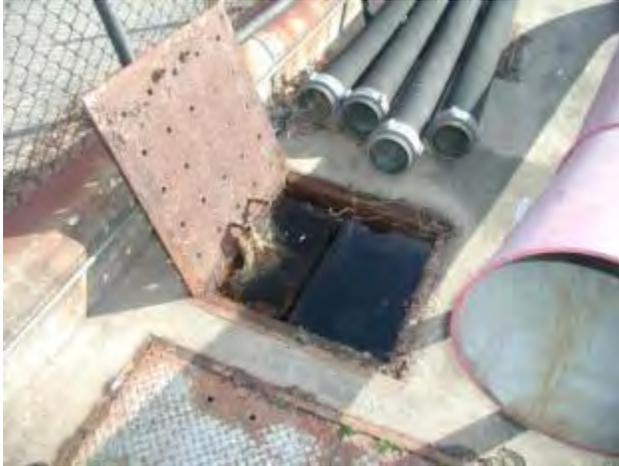
Unused, filled cistern in rear of station

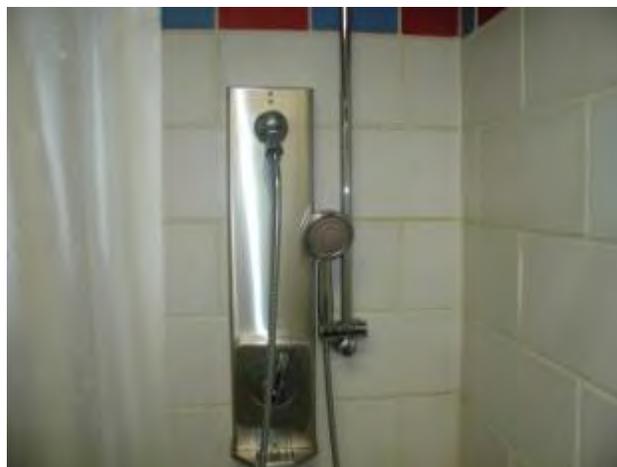
Broken shower head in female locker room

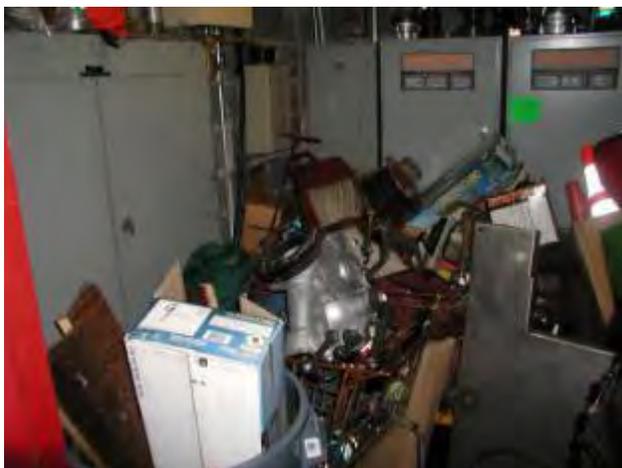
Clutter due to lack of available storage

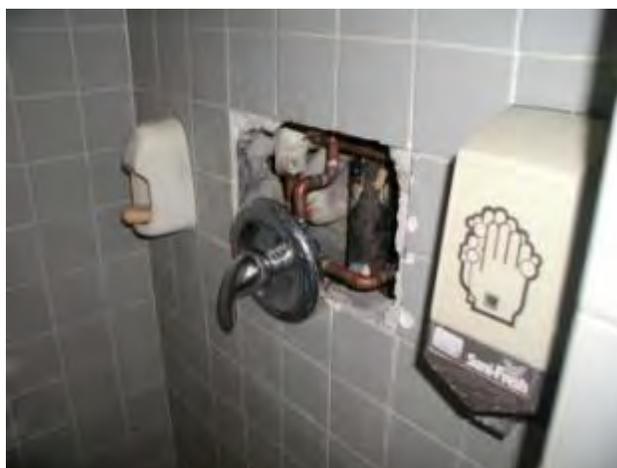
Improperly repaired showers: Employees stated that contractors did not properly repair the showers and piping, and have not returned to correct and complete repairs.

Inadequately repaired shower

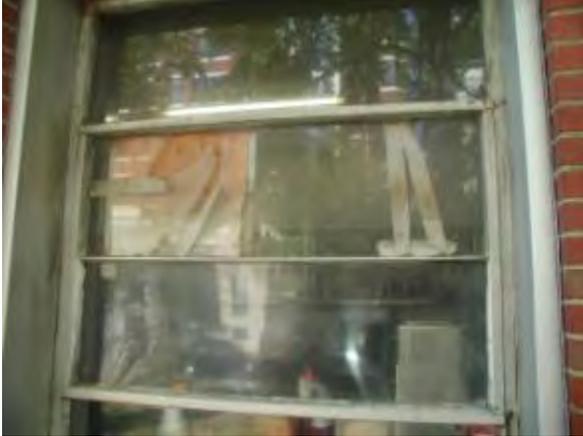
Windows cracked and patched with tape

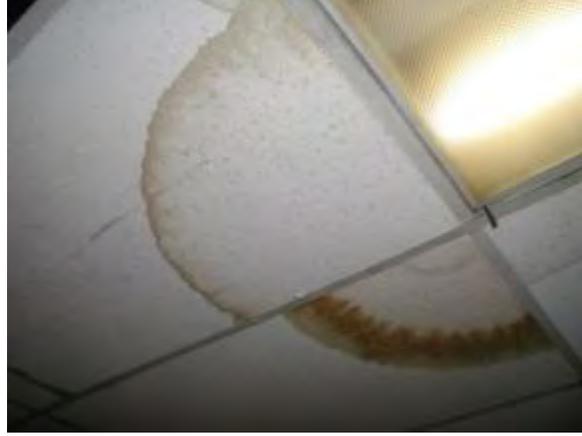
Water damage to ceiling

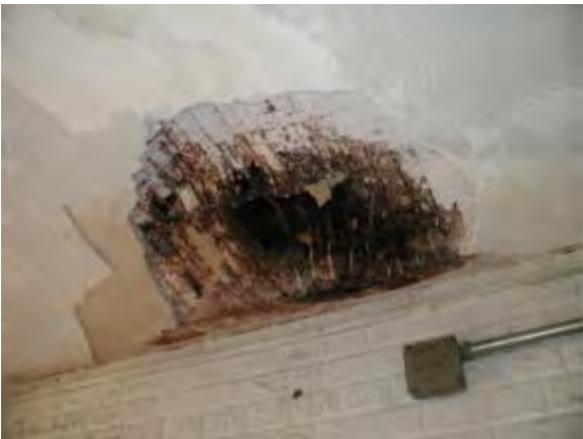
Water damage to ceiling

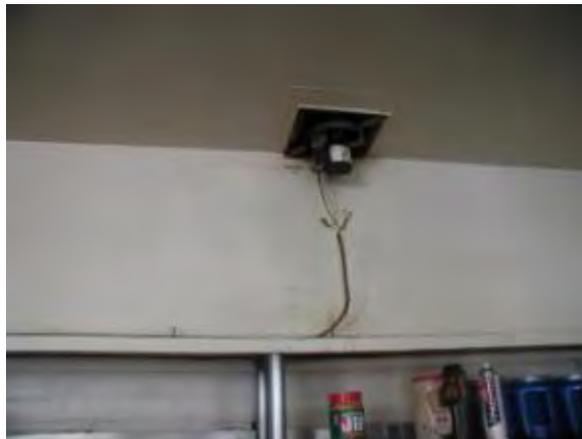
Exposed wiring

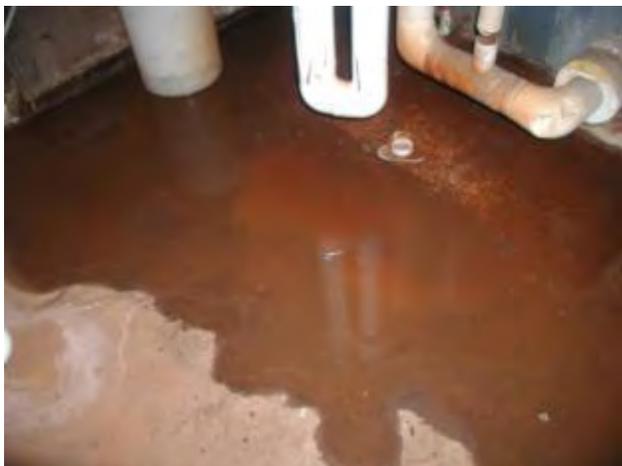
Standing water in basement

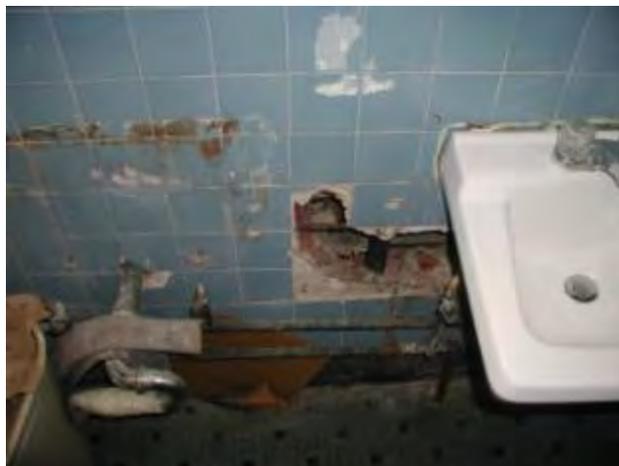
Large hole/cracks in wall of bathroom

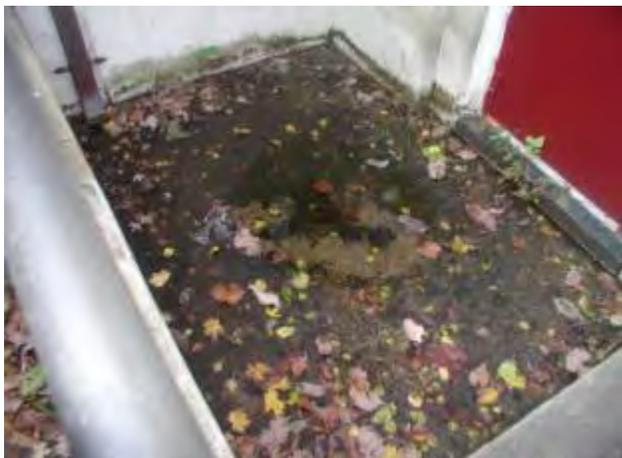
Clogged exterior drain

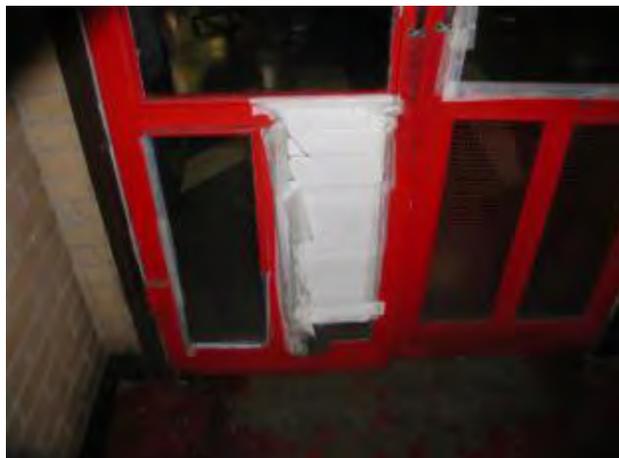
Broken interior door

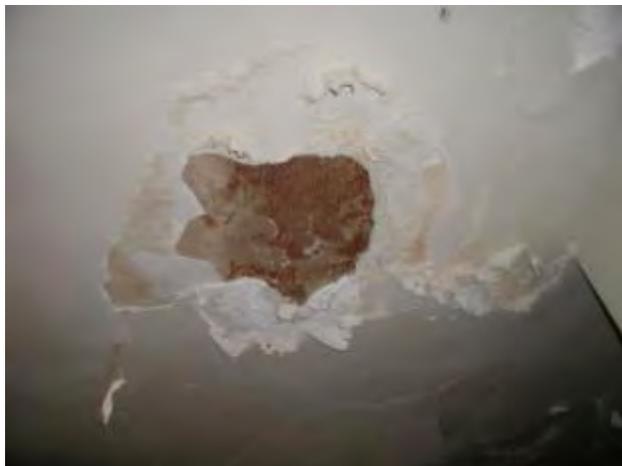
Damaged ceiling

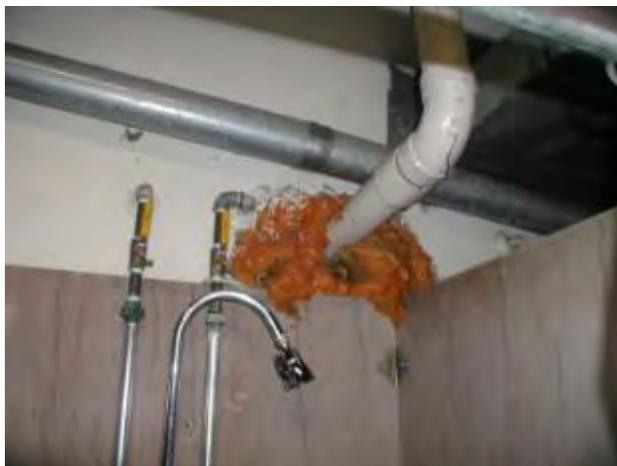
Pipe insulation concerns: Additionally, the team observed excess insulation around the piping leading into the men's bathroom. FEMS employees stated that this condition has existed for a year.

Damage to pipes and walls

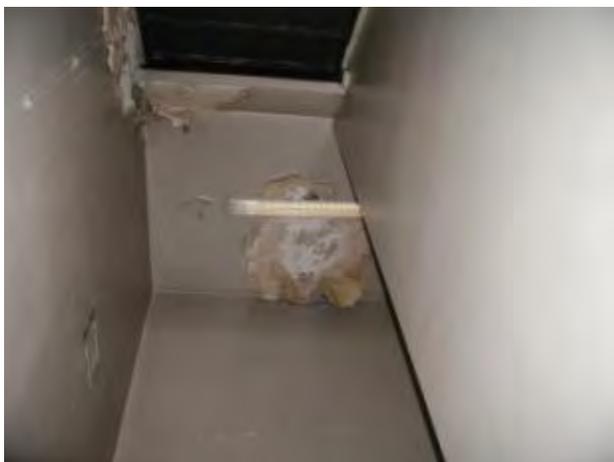
Damaged ceiling

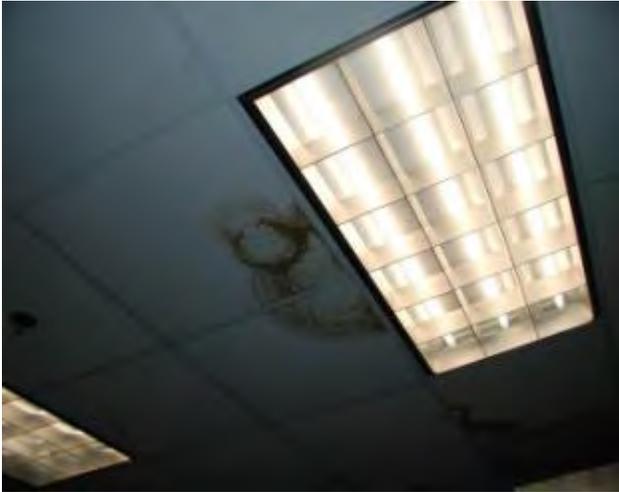
Ceiling tiles: The team observed water damage to the ceiling tiles in the work areas of Engine 17.

Water damaged ceiling

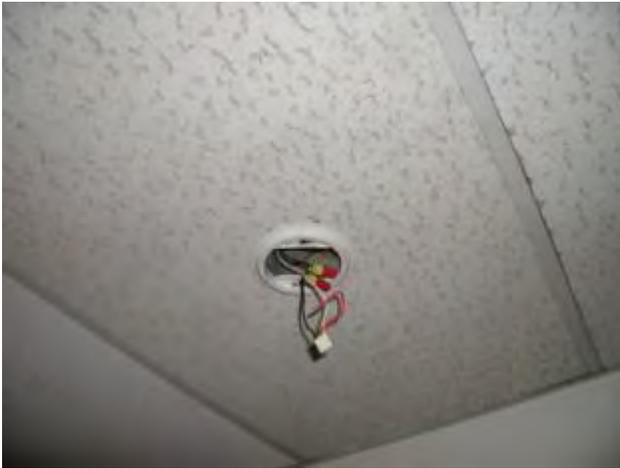
Missing smoke detector

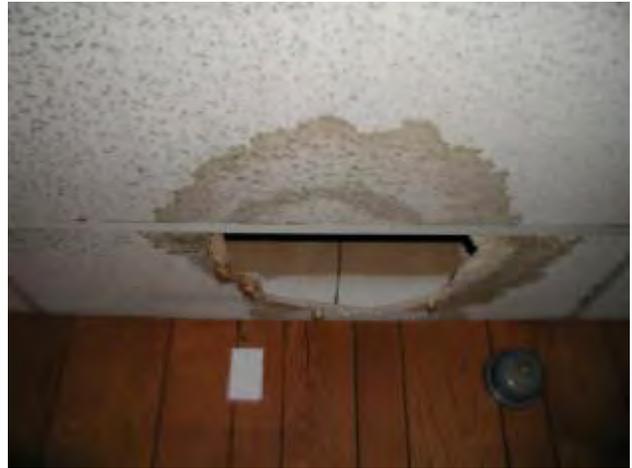
Water damaged ceiling

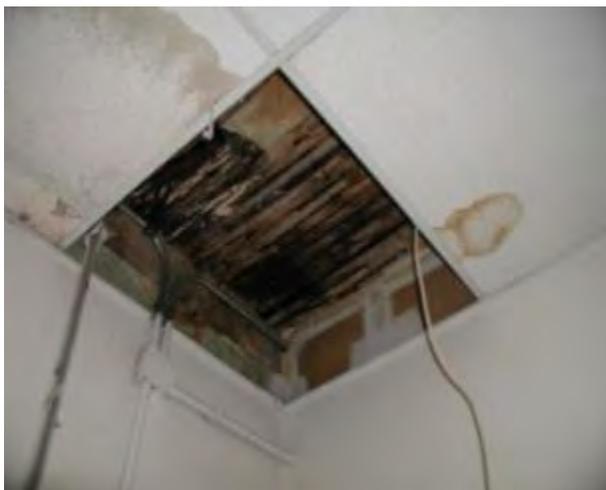
Water damaged ceiling

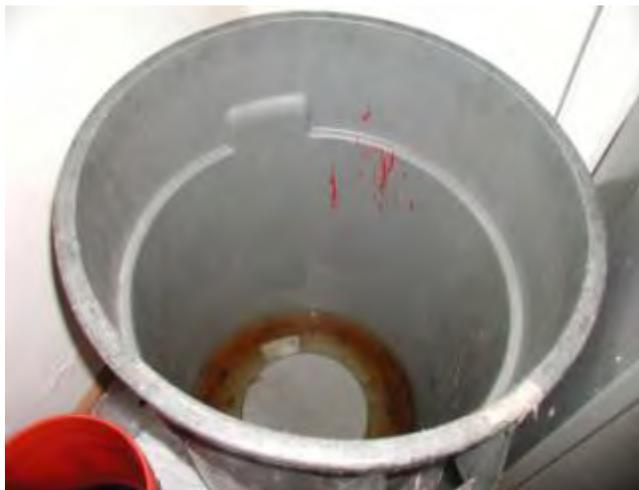
Trash can used to collect water

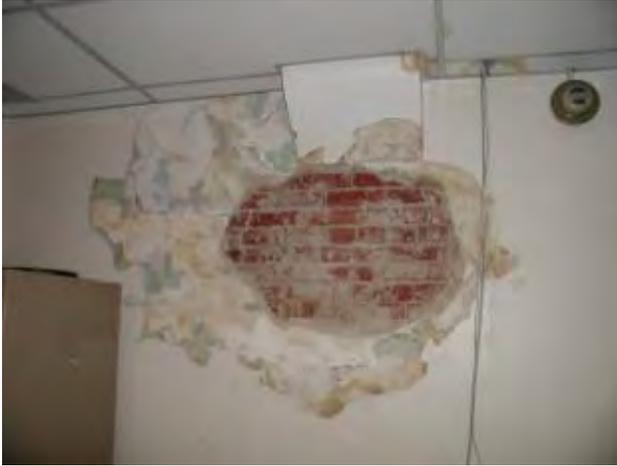
Damaged interior wall

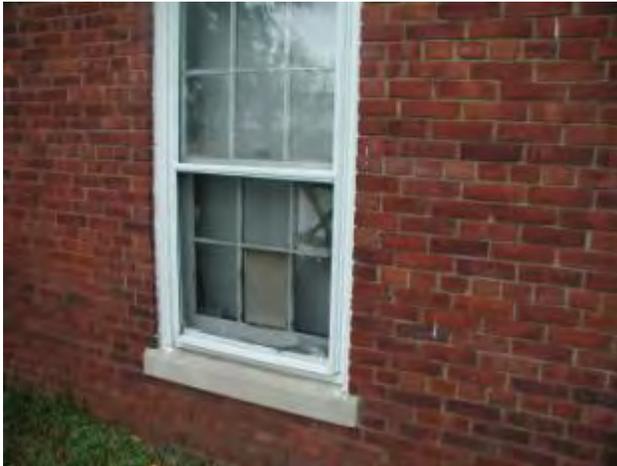
Broken window repaired with cardboard

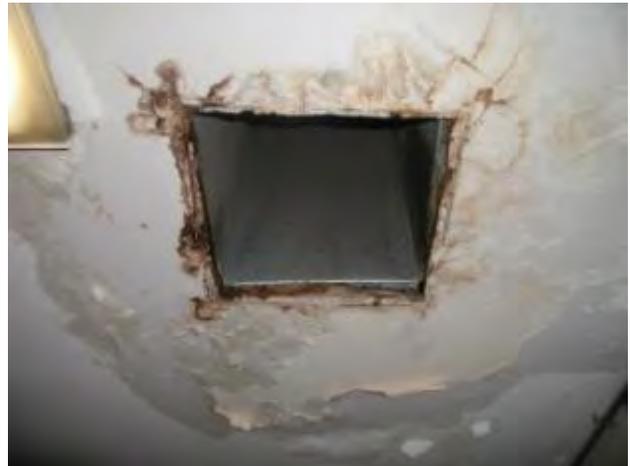
Water damaged ceiling

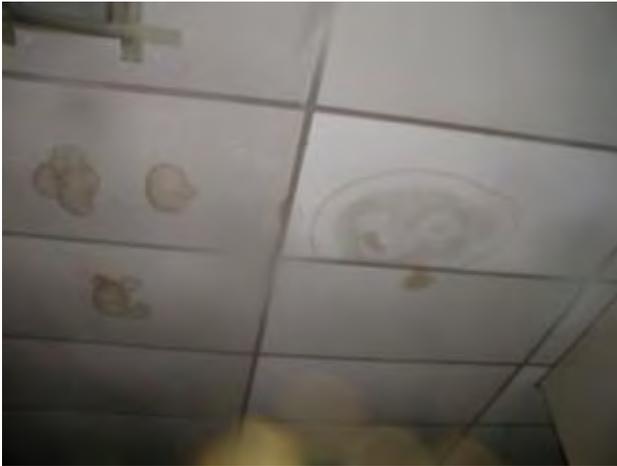
Water damage on ceiling

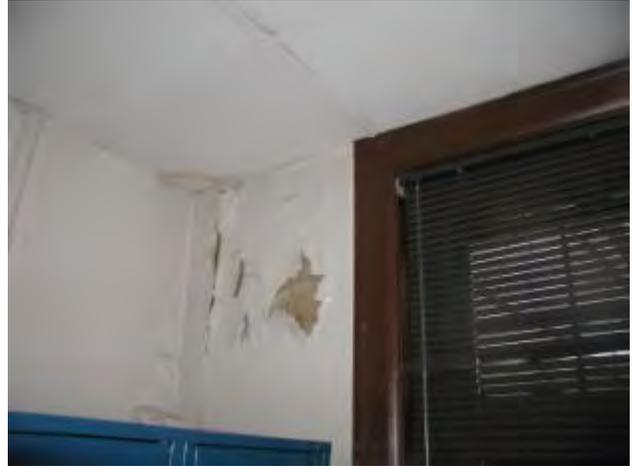
Peeling and chipped paint on walls

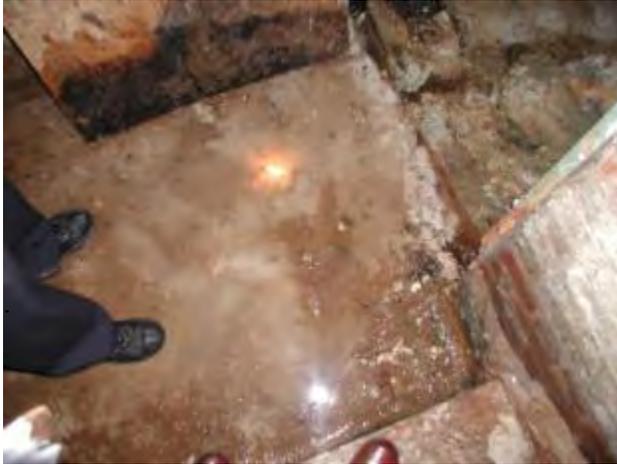
Basement concerns: The team observed water damage in the basement, significant trash piled up, soaked and stagnant insulation, and mold on the walls. Employees stated that they have seen raccoons in the basement, and consequently employees refuse to enter the basement.

Water damage and mold in basement

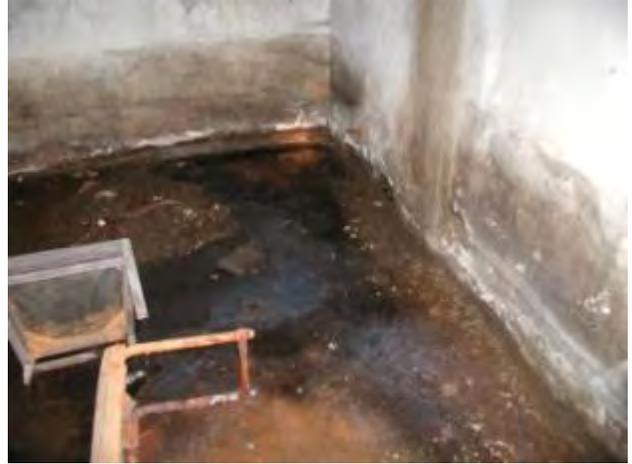
Water damage and mold

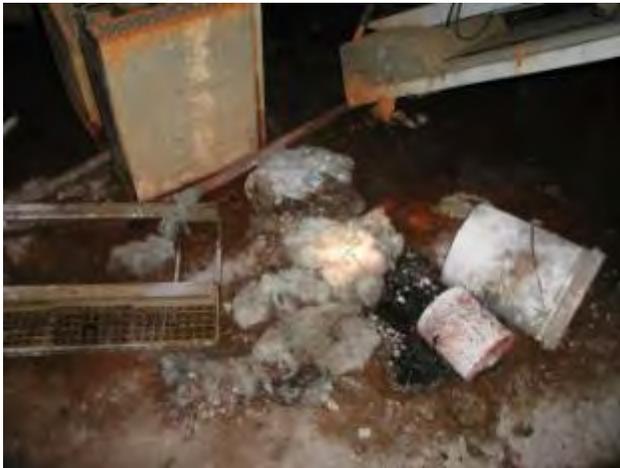
Trash in basement

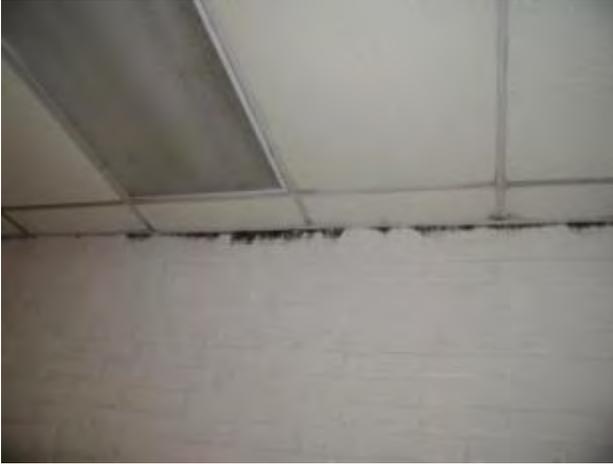
Mold: The team observed mold in the living and working areas of Engine 31. Employees were unsure as to the cause of the mold.

Mold on walls

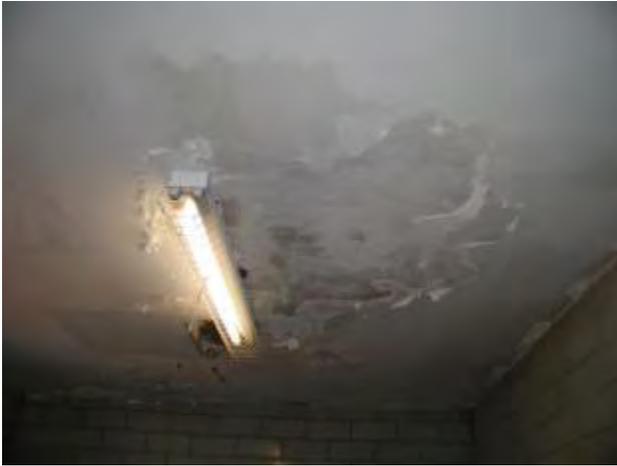
Damaged ceiling

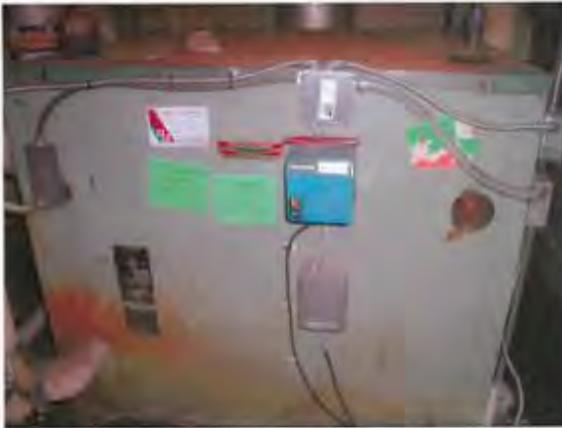
Photo 1. Malfunctioning boiler – Engine 18

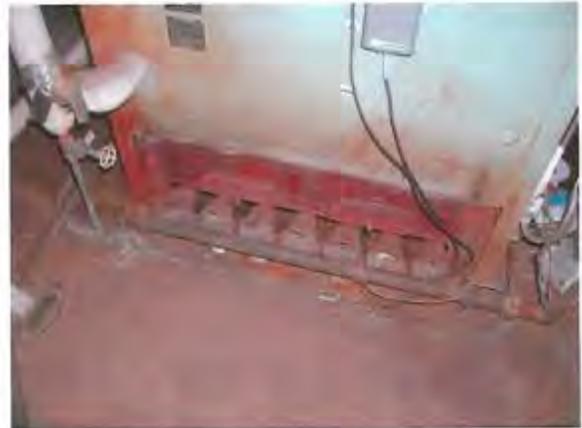
Photo 2. Malfunctioning boiler – Engine 18

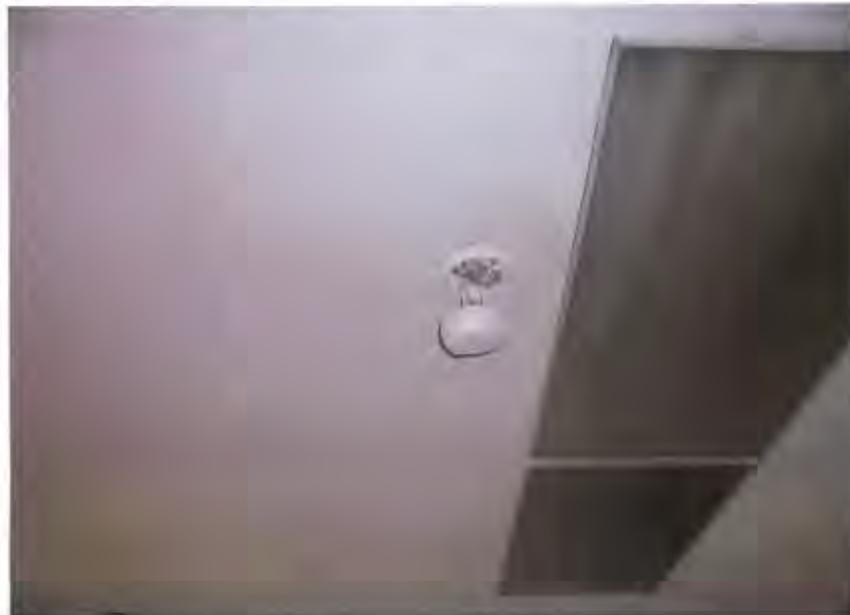
Photo: Inoperative smoke detector – Engine 13

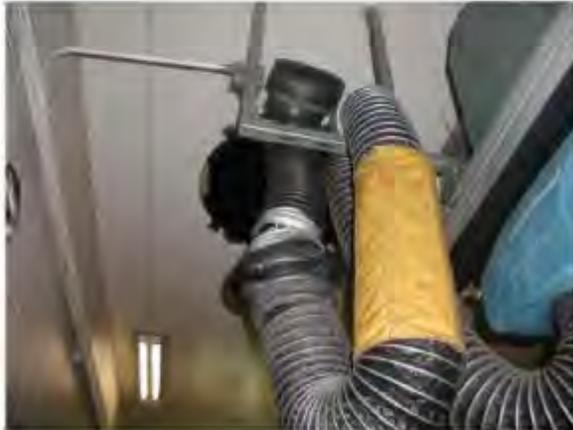
Photo 1. Damaged exhaust system – Engine 18

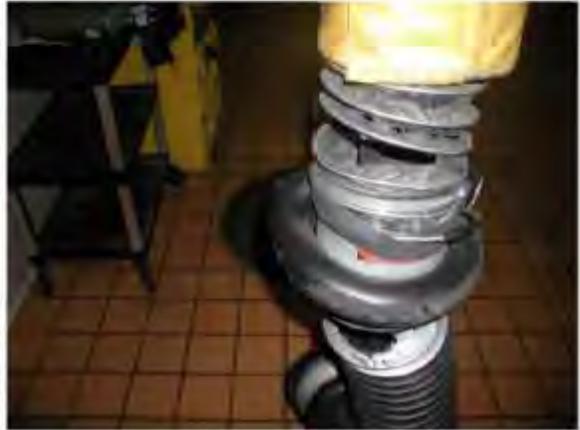
Photo 2. Damaged exhaust system - Engine 18

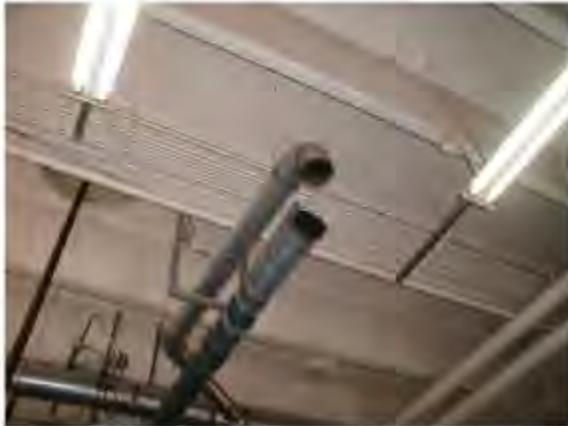
Photo 1. Damaged exhaust system – Engine 33

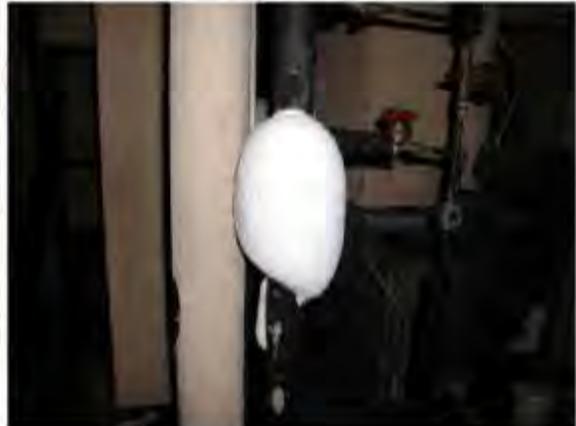
Inoperative exhaust system: In January 2012, FEMS responded to the OIG's Compliance Form for Priority Matter for Station 33. FEMS indicated that the damaged pipe in the boiler room had been corrected. They had obtained a cost estimate to replace the exhaust system and submitted a proposal to DGS for this repair. The team did not receive an update from FEMS that this repair has been made.

Photo 2. Damaged pipe in boiler room- Engine 33

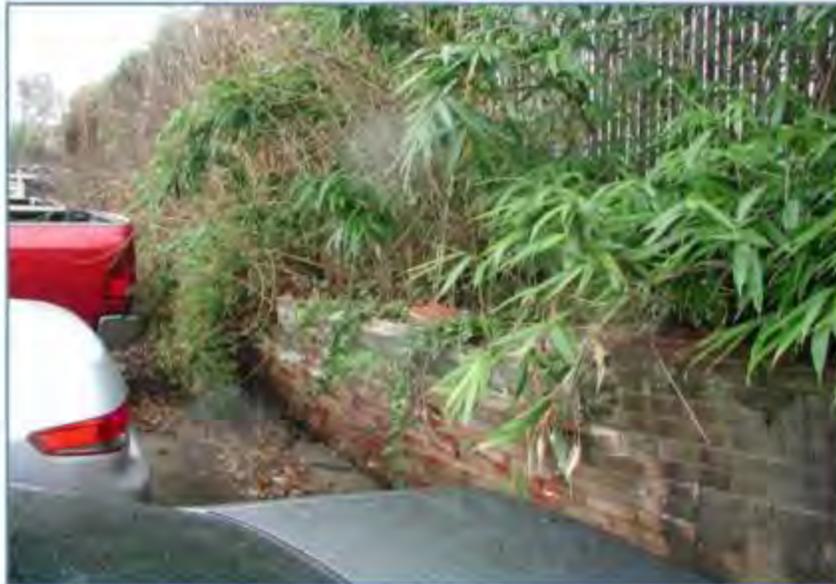
Photo 1. Damaged retaining wall - Engine 15

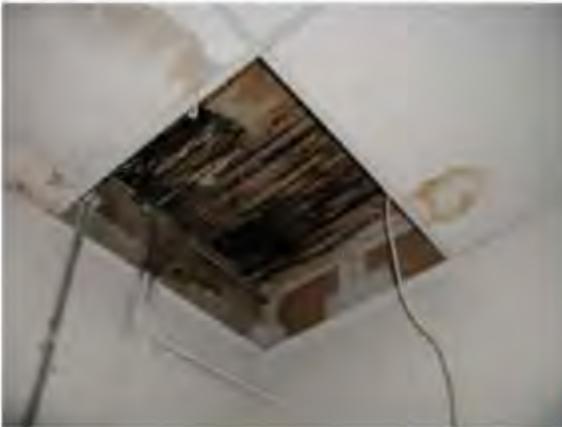
Photo 1. Damaged ceiling – Engine 21

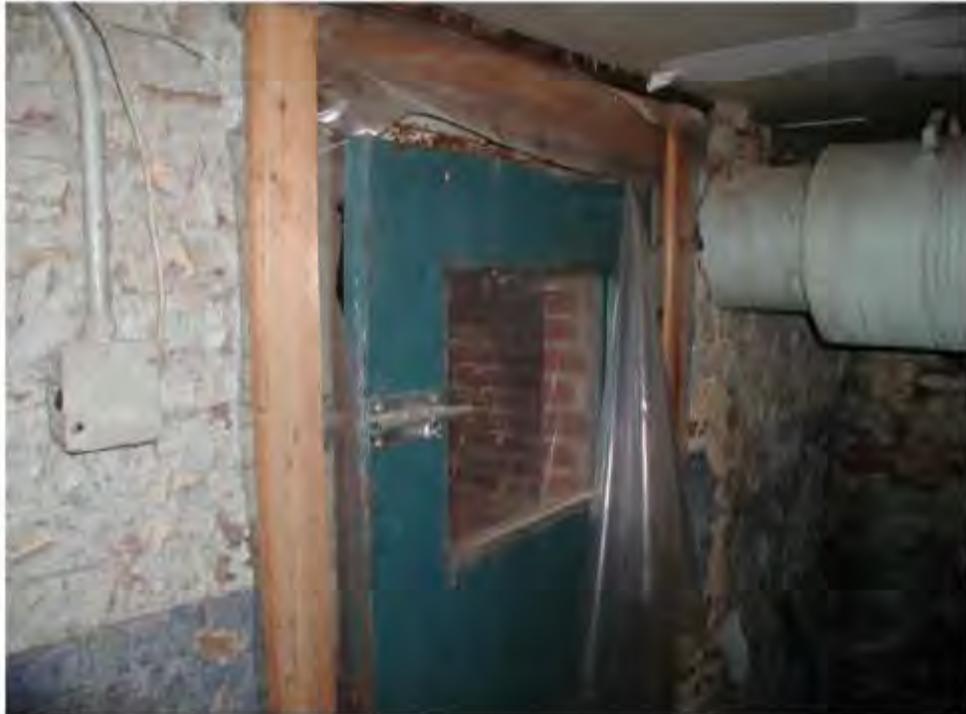
Photo. Inoperable door - Engine 22

In the case of the basement door, DGS has procured a contractor to repair or replace the door to allow opening and closing into that window well area. The project should be completed before March 2nd and I would like to forward a picture when completed.

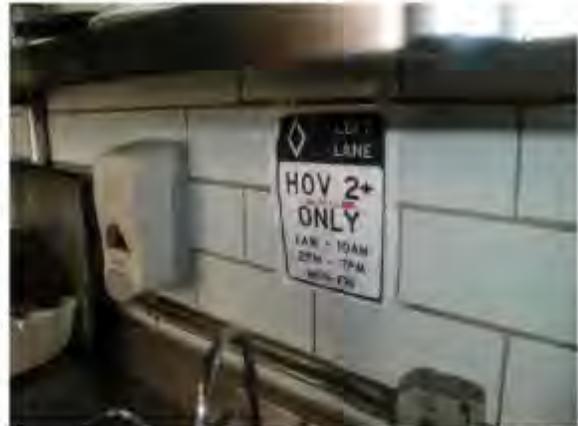
Photo 2. Rodent evidence - Engine 13

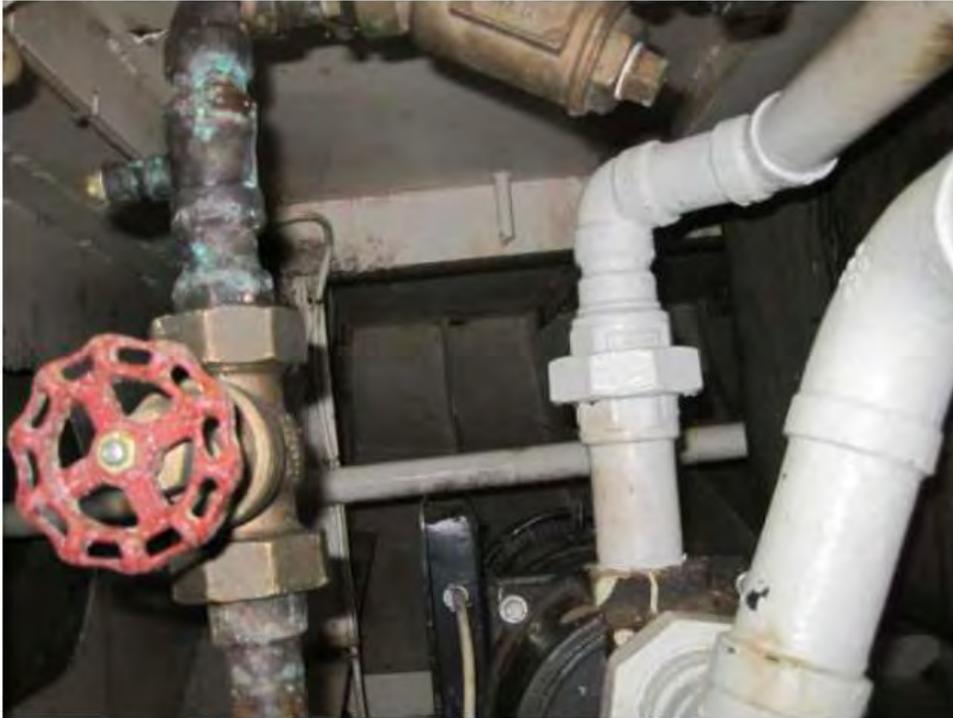
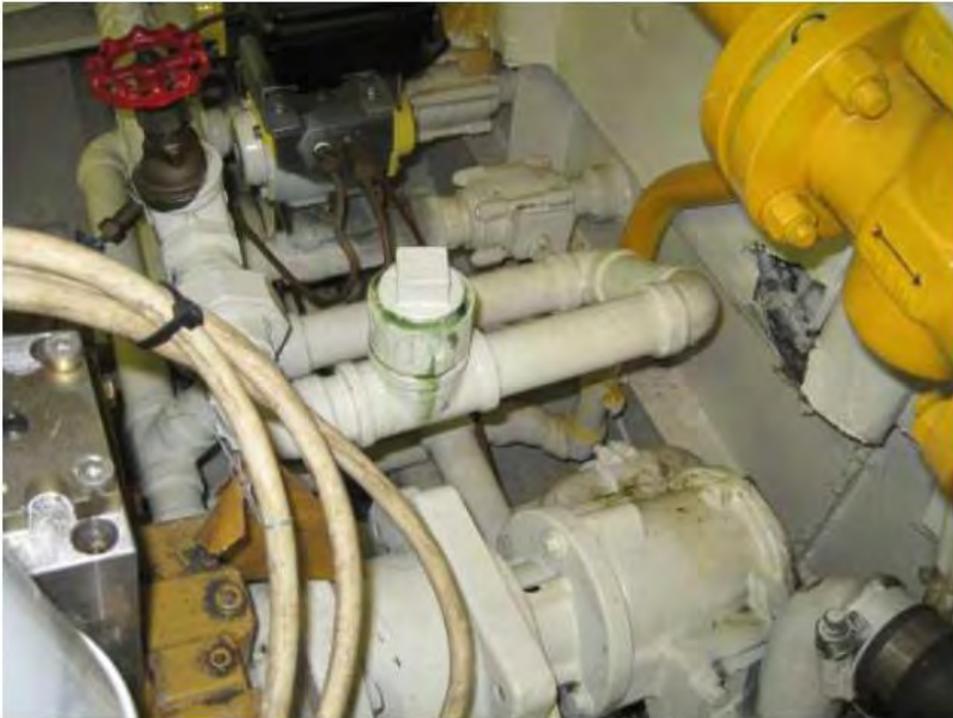
Photo Nos. 9 and 10: General views of piping in bilge areas; note green corrosion/leakage at fitting of foam piping.

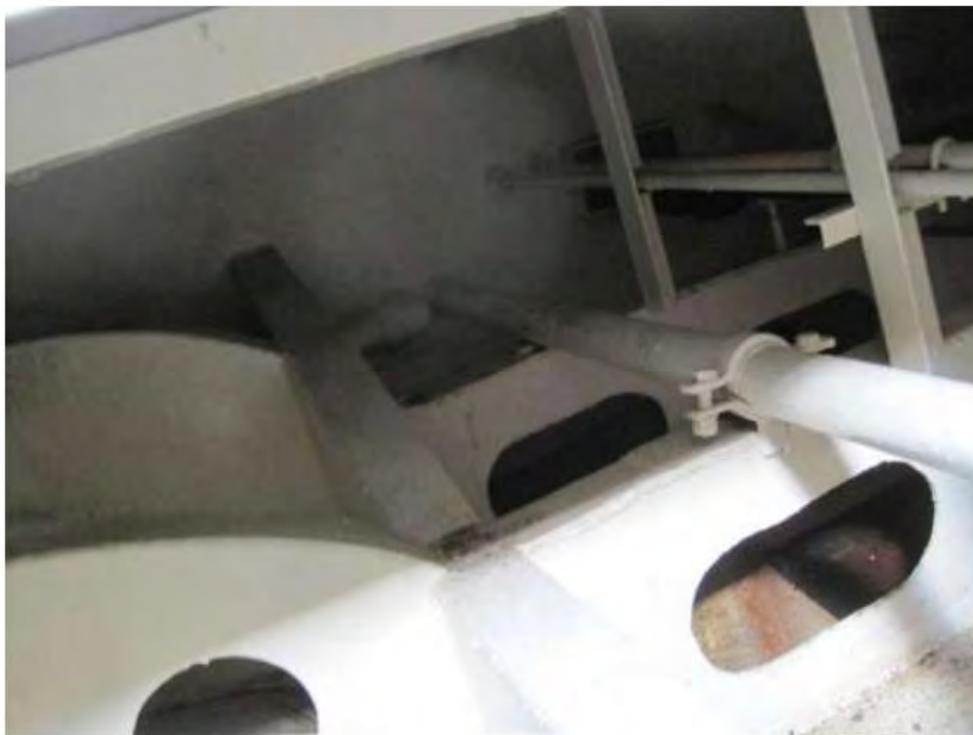
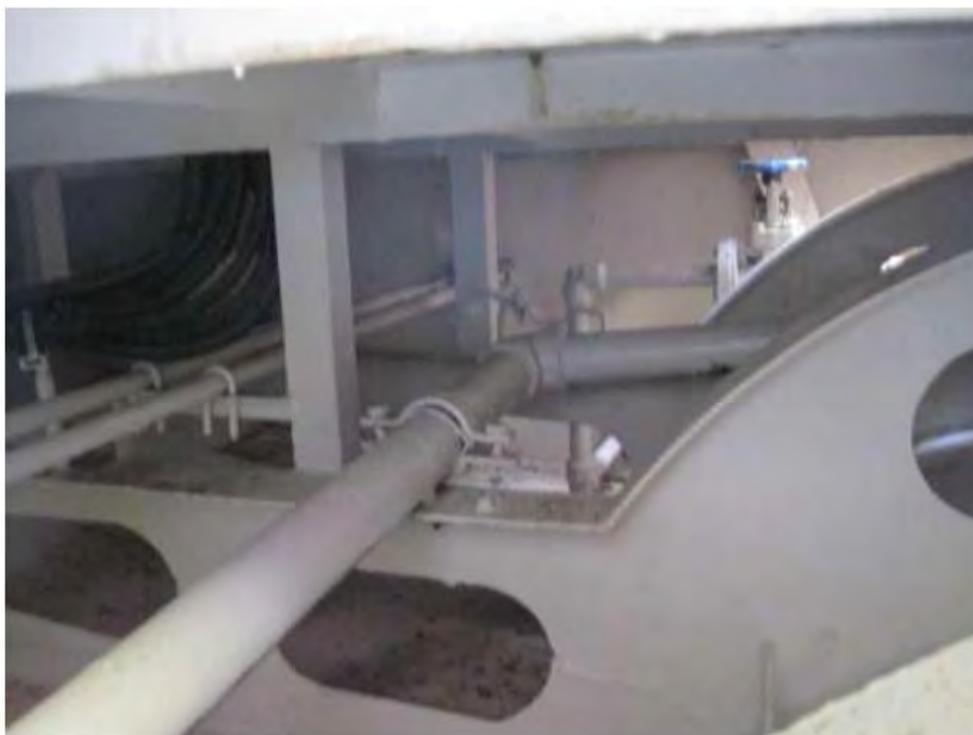
Photo Nos. 11 and 12: General views of bilge area aft of engine room.

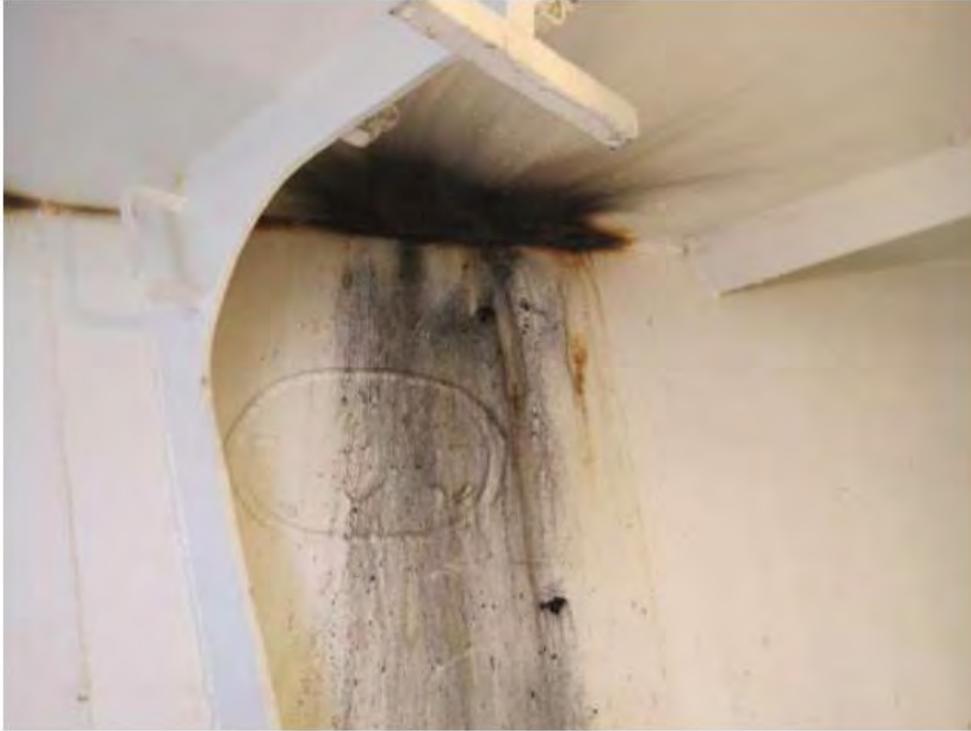
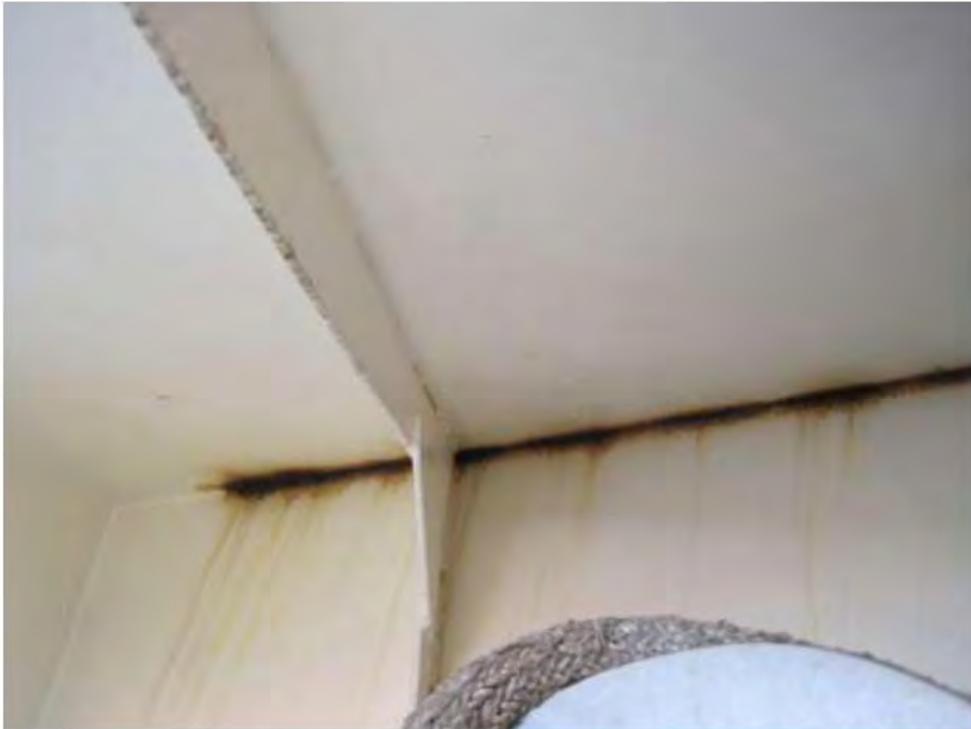
Photo Nos. 23 and 24: Recent welded crack repair in forepeak, port side.
