**GOVERNMENT OF THE DISTRICT OF COLUMBIA
OFFICE OF THE INSPECTOR GENERAL**

**METROPOLITAN POLICE
DEPARTMENT**

**INSPECTION OF
STATION AND SUBSTATION BUILDING
CONDITIONS**

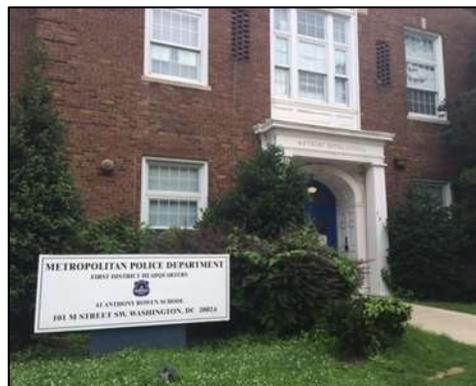
Figure 5: Exterior of First District Station

Conditions noted during our inspection: This station was the most recently renovated and presented the most professional image of a police department to visitors and employees as compared to the other stations and substations. The station was generally clean and well-maintained. The most noticeable deficiencies were:

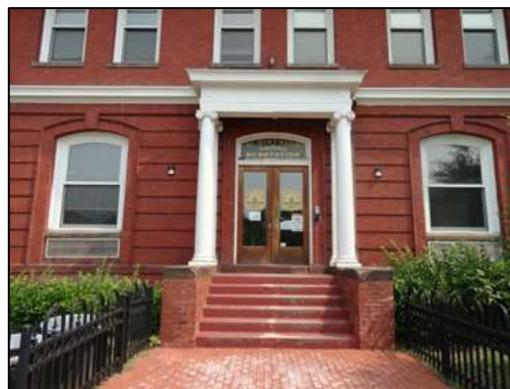
Figure 8 (Above): Exterior of First District Substation

Conditions noted during our inspection: The substation presented a professional image and appeared clean. The most concerning facility conditions were:

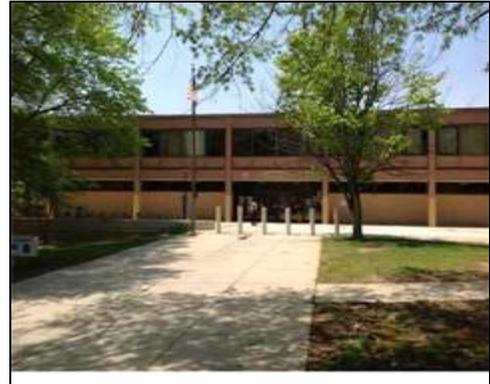
Figure 10: Exterior of Second District Station³⁰

Conditions noted during our inspection: The most concerning building conditions were:

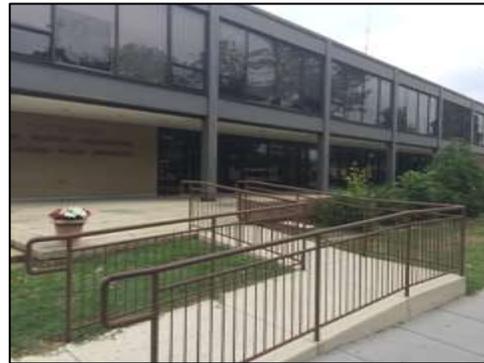
Figure 19: Exterior of Fourth District Station

Conditions noted during our inspection: The most concerning building conditions were:

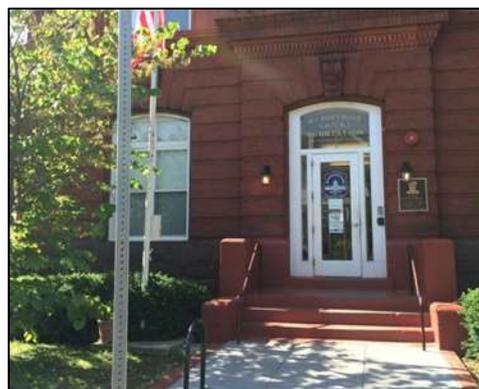
Figure 22: Exterior of Fourth District Substation

Conditions noted during our inspection: The substation was clean and presented a professional image. The most concerning building conditions were:

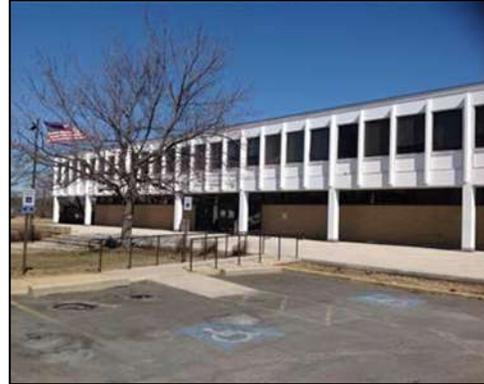
Figure 23: Exterior of Fifth District Station³⁸

Conditions noted during our inspection: The most concerning conditions in this station were located in the holding cell area. Small holes in the wall caused by plaster deterioration were present behind the toilet inside the largest holding cell, which allowed prisoners to hide contraband.³⁹ While we were on-site, an MPD officer reached into one of these holes and found two shoe insoles, “baggies” used for narcotics, as well as an old razor blade. The officer noted that this deterioration has been a longstanding condition. The light in the female restroom in the holding area provided another potential place for prisoners to store contraband, but no contraband was observed in this location. Additionally, the clock in the processing area of the holding area was broken and had sharp plastic edges, which could be used as a weapon. These conditions are safety concerns.

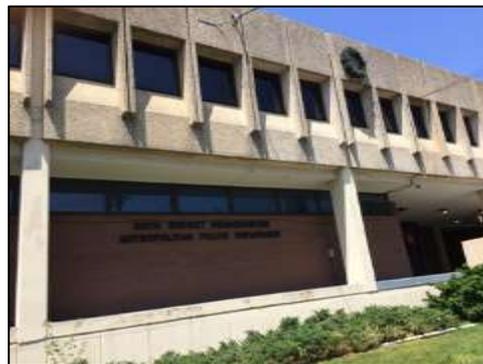
Figure 28: Exterior of Sixth District Station

Conditions noted during our inspection: Room 140 (the area used by undercover officers) was in the worst condition; it contained safety hazards such as a door off its hinges and storage behind it, broken blinds, and surplus materials.

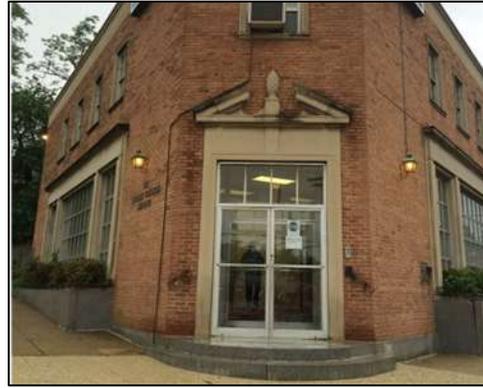
Figure 35: Exterior of Sixth District Substation

Conditions noted during our inspection: The substation was clean and presented a professional image. The most concerning building conditions were:

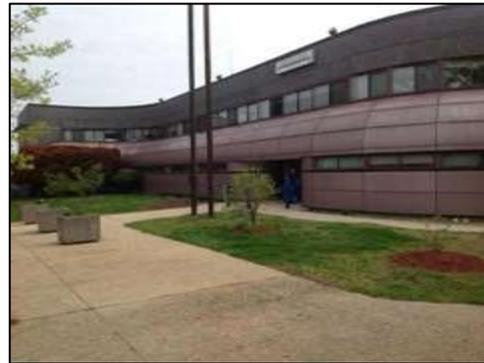
Figure 37: Exterior of Seventh District Station⁴⁶

Conditions noted during our inspection: This station was clean and presented a professional image. Part of the station was recently renovated, and appeared well-maintained. The most concerning building conditions were:
