**GOVERNMENT OF THE DISTRICT OF COLUMBIA
OFFICE OF THE INSPECTOR GENERAL**

REPORT OF RE-INSPECTION

**CONDITIONS IN FIRE AND EMERGENCY
MEDICAL SERVICES DEPARTMENT
FIRE STATIONS**

November 2012

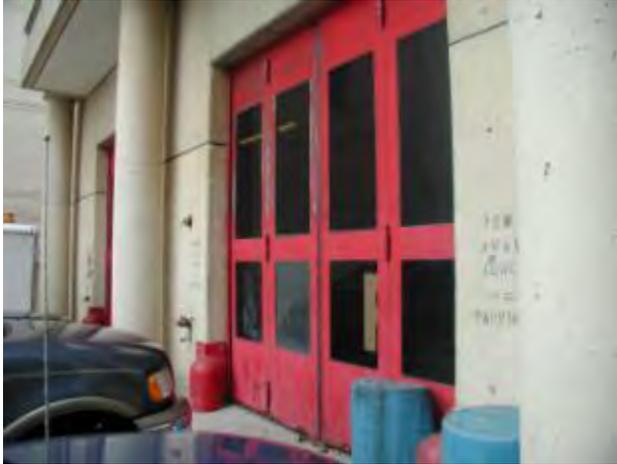
Rear apparatus doors: Employees stated that both rear apparatus doors have been inoperative for 2 years and, as a result, are not used for apparatus egress.

Inoperable rear apparatus doors

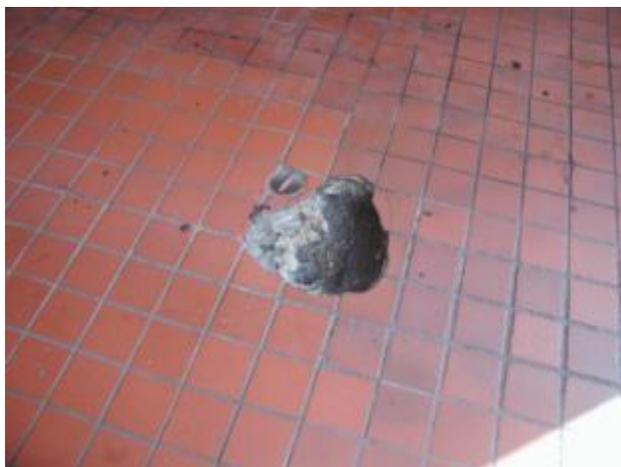
Large hole in apparatus floor

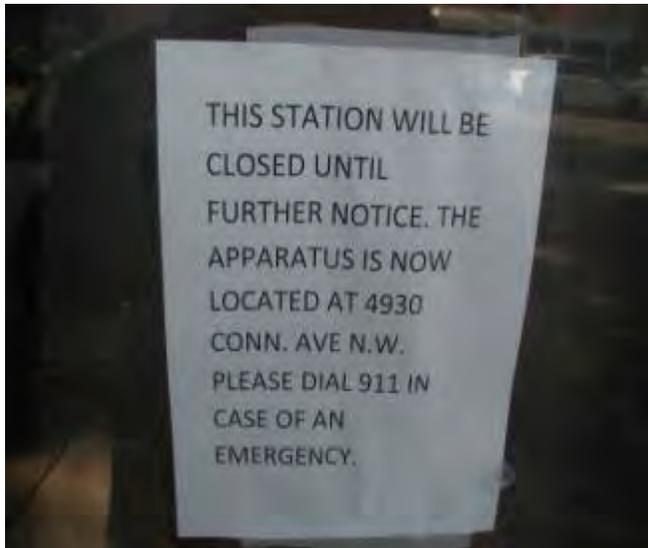
On the day that the team went to observe Engine 28, it was closed for renovation, and re-inspection fieldwork did not occur at this location.

Posted sign at Engine 28 on date of observation

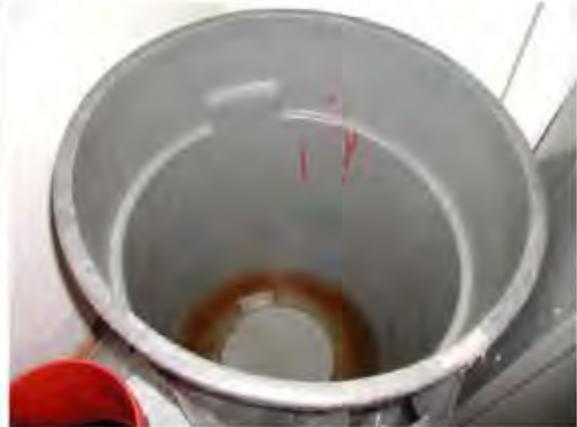
Photo 3. Rainwater collection – Engine 21

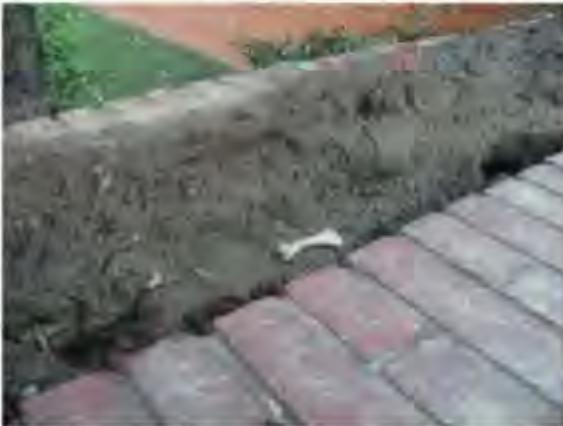
- Engine 1 – FEMS members stated that there is a serious problem with rodents. The inspector observed multiple rodent holes dug into the ground on the exterior of the house; droppings, and a worn path that rodents travelled on. Members stated that they have found rodents in their personal vehicles chewing the electrical wires and causing vehicular problems. Rodents have also been seen in the kitchen and locker rooms, have been found in food storage areas, in the stove, and seen crawling across pots and pans. (See photo #1)

Photo 1. Rodent Evidence – Engine 1

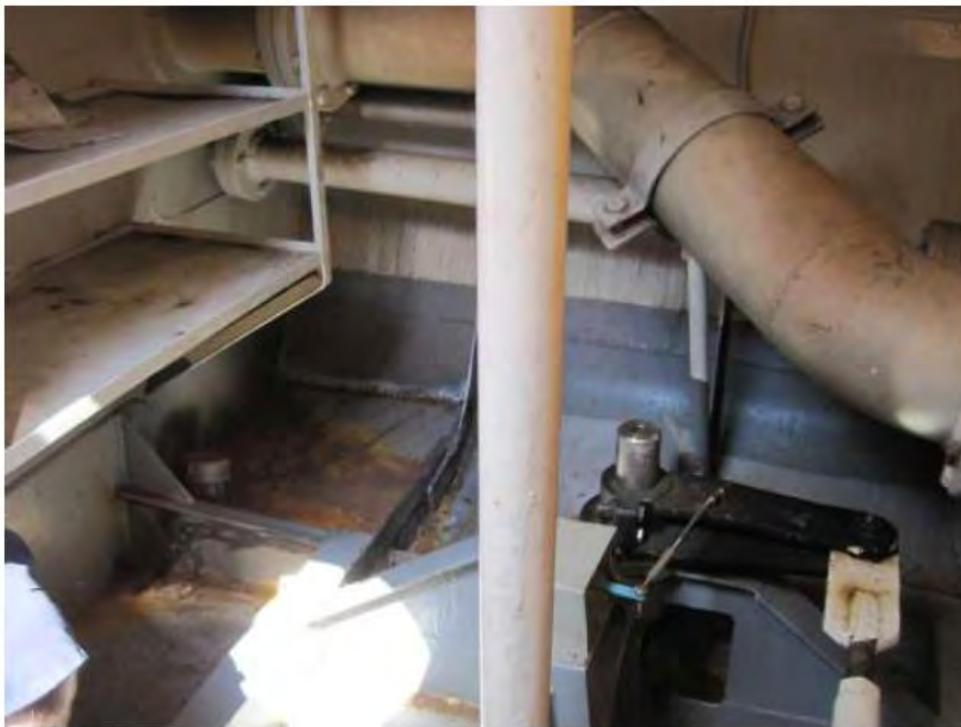
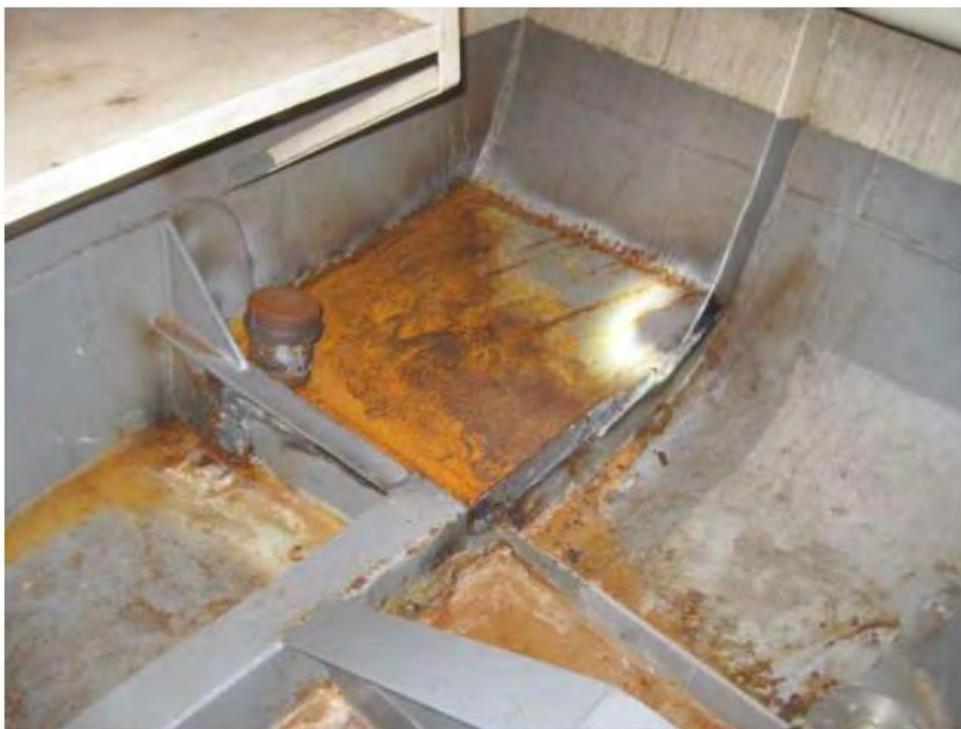
Photo Nos. 13 and 14: Cement patch in forward starboard corner of lazarette.

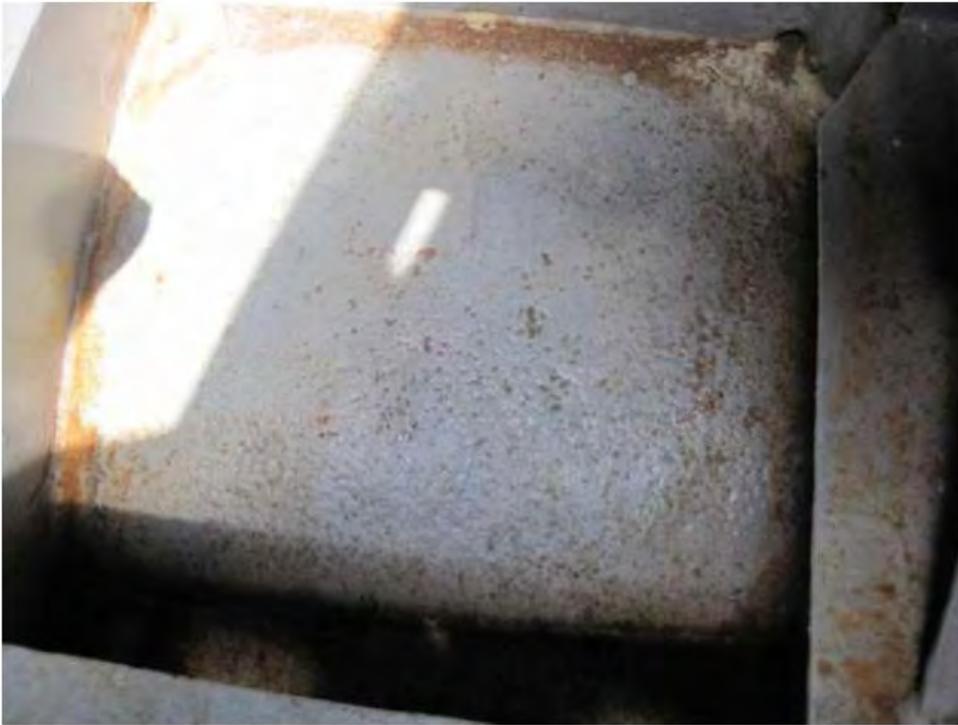
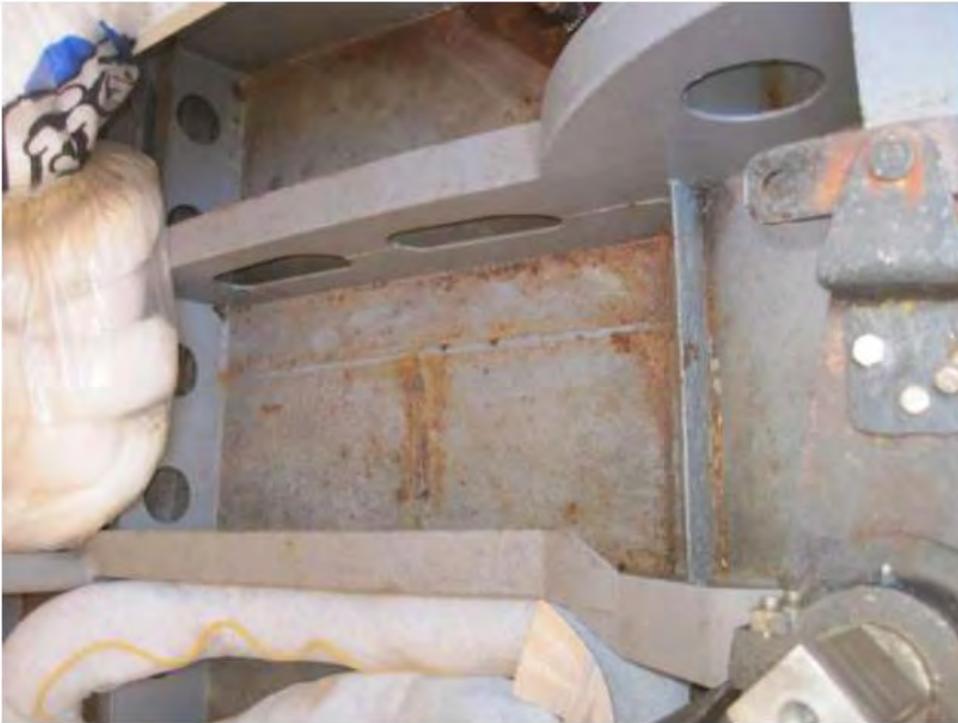
Photo Nos. 15 and 16: Pitted plating in lazarette.

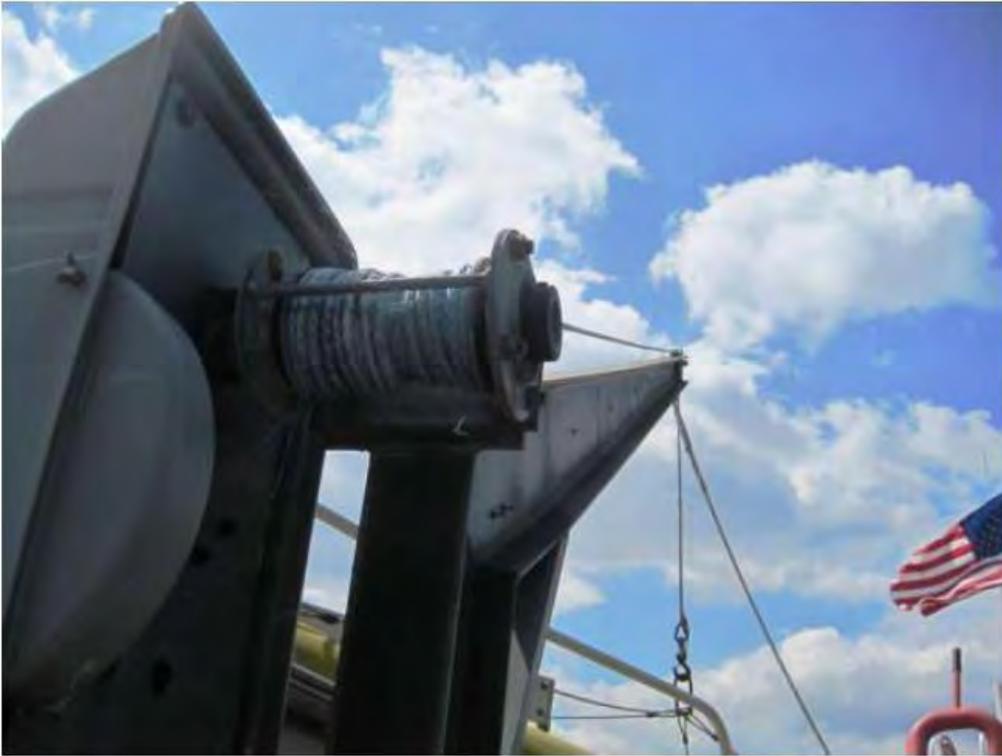
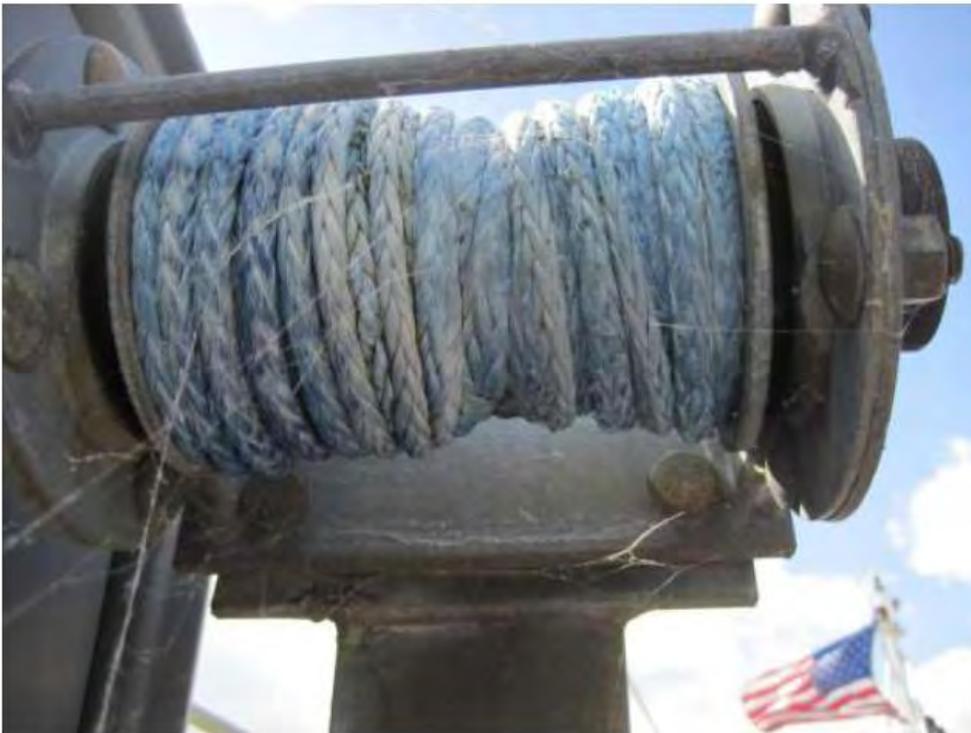
Photo Nos. 17 and 18: Faded Kevlar boat davit fall.
